VOICE SITES

PORTUGAL

IMPROVEMENT OF A TWO-LANE MAIN RURAL ROAD INTERSECTION

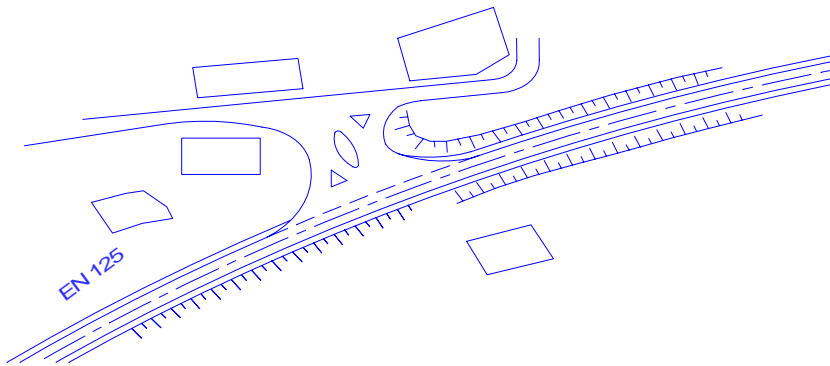
The intersection provides access to a small village situated near the road. In this area the road has a 750 m radius horizontal curve; longitudinal profile is almost level, with less than 1% upgrade. This is a T-junction, with the minor road arm on the outer side of the curve (see Figure below).

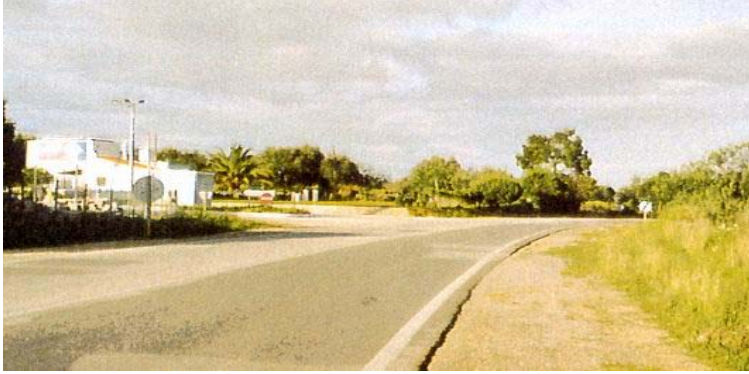
The 7.00 m wide carriageway on the main road is divided in two lanes, one for each direction. Pavement wearing course is made of bituminous concrete. Non-paved 2.50 m wide shoulders are provided on each side of the carriageway. This junction is part of a small five kilometre stretch of road with unpaved shoulders; shoulders are paved and 2.50 m wide in the remaining 25 km of this road stretch.

1. Construction of paved shoulders along the five kilometre stretch that includes this intersection in order to improve main road consistency, enhancing the possibilities for emergency manoeuvres and providing safer routes for pedestrians.
2. Corrective measures for the minor road included a better separation of traffic flow, reducing the space available for manoeuvring from the street and providing a better guidance for the required trajectories to and from the main road.
3. Improper speed choices on the main road was addressed by measures applied to the entire itinerary.

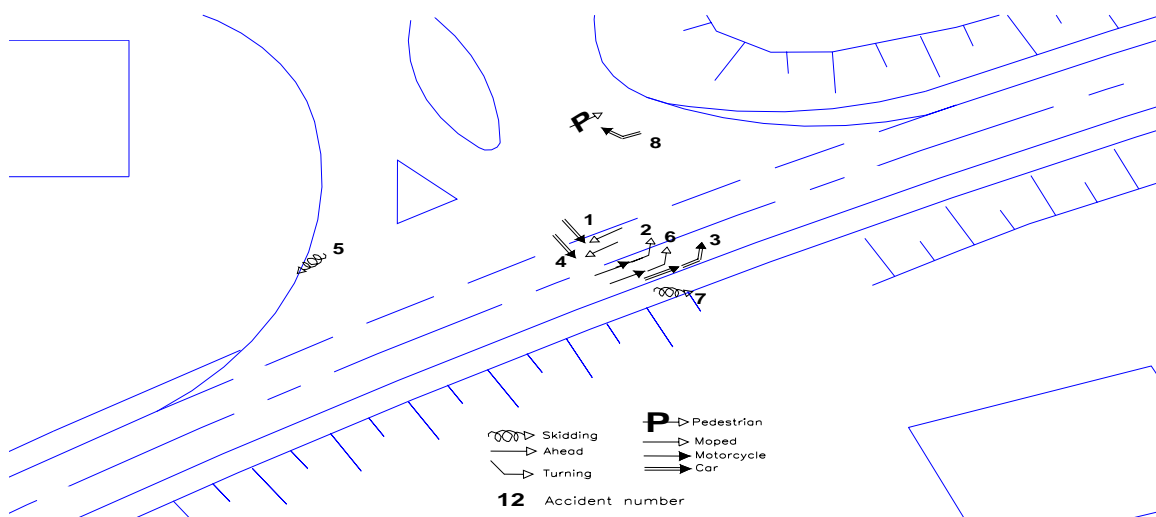
Eight injury accidents, involving six cars, four mopeds, three motorcycles and one pedestrian, were reported to the police on this black spot during a 5 year period, resulting in 13 slightly injured victims and no fatalities. Half of the accidents occurred at night; only two accidents occurred during the summer season (April to September). Crashes include two lateral collisions and four rear end collisions. An accident diagram is provided below:

High traffic speeds on the main road may render detecting powered two wheelers difficult, which partially explains the great involvement of this type of vehicle in accidents.

Lack of adequate traffic flow separation road markings contributes to attempts to perform them at high speeds, resulting in potential sudden speed changes (hard braking) in case of erroneous behaviour correction. Emergency reacting by drivers is complicated due to the unexpected absence of available paved shoulders (as in previous intersections).
