VOICE SITES

Improving VRUs safety at the section of Grochowska Street, Warsaw

The study was conducted by the University of Technology in Gdansk, Civil and Environmental Engineering Faculty, Highway Engineering Department, Krzysztof LINKE (Team PG-01), under the supervision of Dr. Inz. Kazimierz Jamroz.

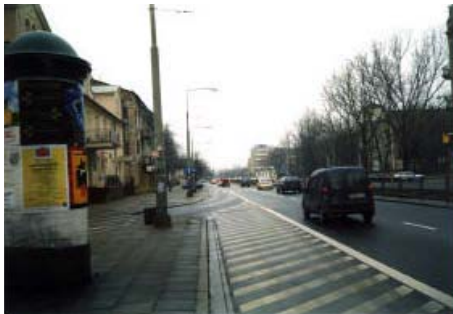
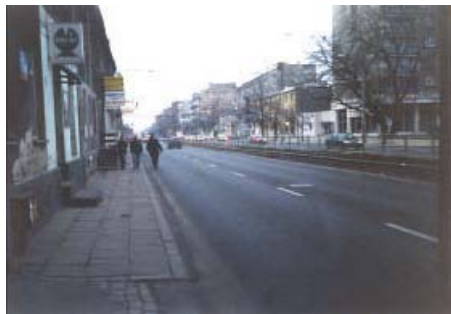
The pedestrian crossing in Warsaw at Grochowska Street, 355 is very dangerous for traffic participants. Therefore, it was selected for the International Student Competition to improve the safety of vulnerable road users at urban intersections organised by the European Transport Safety Council in cooperation with the Motor Transport Institute in Warsaw.

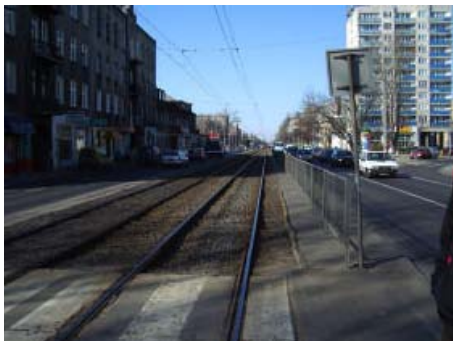
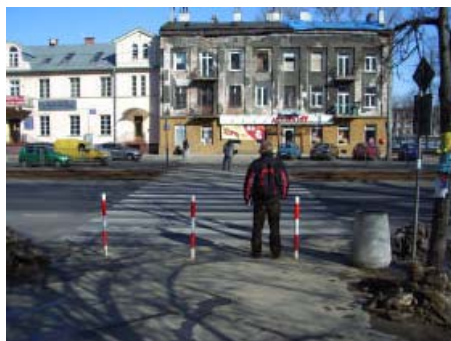
The assessment showed that there is a high volume of motor vehicle (almost 4000 v/h in both directions in the area of pedestrian crossing) and tram traffic (38 trams per hour) at Grochowska Street making it difficult for pedestrians to cross the street along the pedestrian crossing safely. Speed measurements conducted with radar speed indicators in the proximity of analysed pedestrian crossing in both directions showed that more than 60 % of drivers in the direction of Wiatraczna Roundabout and 40 % of the drivers in the direction of Zieloniecka Street exceed speed limit of 50 km/h.

The majority of accidents involving pedestrians takes place directly on the pedestrian crossing. The reasons may be various but the most important is the location of pedestrian crossing. The recorded collisions involving pedestrians do not include fatal accidents, however given the recorded speed and a large number of collisions, a further increase in the number and severity of accidents may be expected.

The pavement on the right side of roadway is also very dangerous. For people in wheelchairs and the blind it constitutes the barrier impossible to break through because of numerous stairs, steps and the vicinity of fast moving vehicles. The pedestrian crossing at the adjacent Minska Street, as well as the entry from this street, requires modernization. The entry location at an angle close to 30 degrees to Grochowska Street, together with acceleration lane, encourages drivers to drive fast. It was observed that cars speeding from Minska Street literally run into the pedestrian crossing without any possibility to check the situation there because visibility for entering cars is blocked by the vehicles parking on the pavement directly in front of the pedestrian crossing.

- **Change in Grochowska Street axis in the direction of Minska Street.** The change will allow for formation of pedestrian refuge island (of minimal width of 3 metres), where pedestrians, cyclists and people in the wheelchairs will be able to wait safely to pass the next stage of the crossing.

- **Moving the pedestrian crossing behind the entry of Minska Street.** It will allow for decreasing the width of roadway necessary to pass at one go, it will enable better communication between two sides of Grochowska Street and moves the pedestrian crossing out of acceleration and deceleration lanes.

- **Change of Minska Street entry construction into perpendicular passage to Grochowska Street,** which will force drivers to increase their caution, will decrease speed and significantly improve visibility.

- **Installation of traffic lights** at the pedestrian crossing (synchronised with the intersections in the area), which will make it safe, especially for the youth attending the nearby school.
