TRAFFIC SAFETY ANALYSIS ON HIGH-ACCIDENT ROAD SECTIONS IN LITHUANIA

1. Traffic safety analysis on the road section across the Krosna village, in 34,477-36,851 km of the national road No. 131 Alytus-Simnas-Kalvarija

2. Traffic safety analysis and identification of the need for traffic safety measures at 79,57 km junction of the main national road No. A16 Vilnius-Prienai-Marijampolė

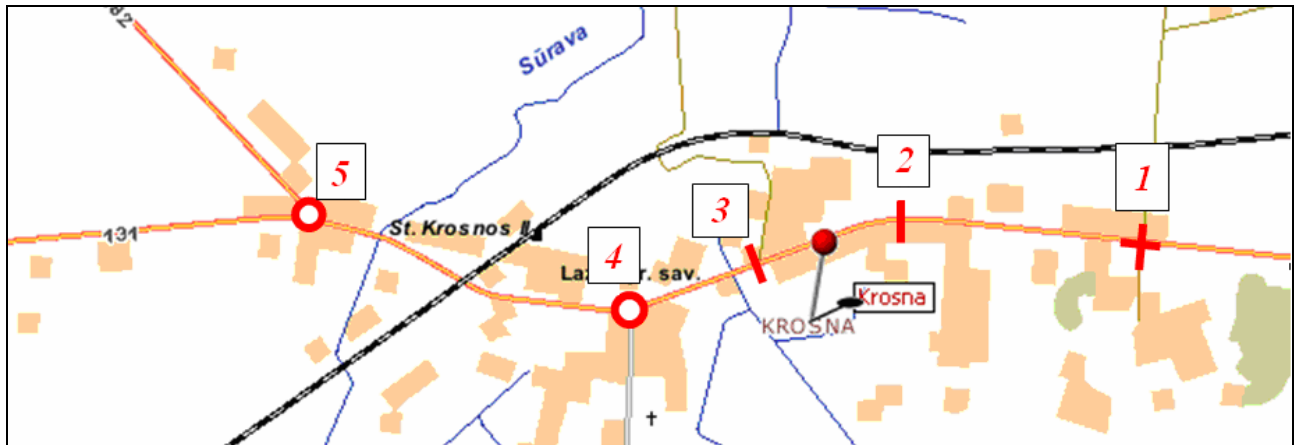
Fig. 1.1. Characteristic locations of the road section under consideration

For the analysis of accident causes, their character and distribution the road section, crossing the territory of the village, is divided into certain road segments or separate road infrastructure elements where the traffic character and the needs of the road users may differ.

1. A four-arm junction in the beginning of the village (1) could help reduce speed if it is properly built. In this case it is advisable to build a junction on a raised plateau. This would help to prevent speeding and careless driving while crossing the major road.

2. Behind the junction there is a rather long and straight road section (from the junction to the central area of the village – about 1300 m long) allowing the driver to speed up. Additional speed reduction measures shall be implemented up to the central zone of the village. As a speed reduction measure a pedestrian crossing on a raised plateau shall be erected. A pedestrian crossing shall be located at a three-arm junction at 35.00 km (2) or close to it (Fig. 1.2.). When selecting precise location for a pedestrian crossing the visibility and the needs and wishes of local residents should be taken into consideration.

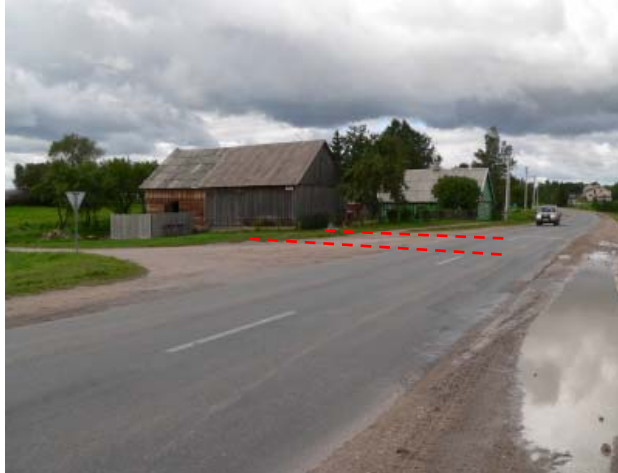
Fig. 1.2. Pedestrian crossing at a three-arm junction to the group of residential houses (2).

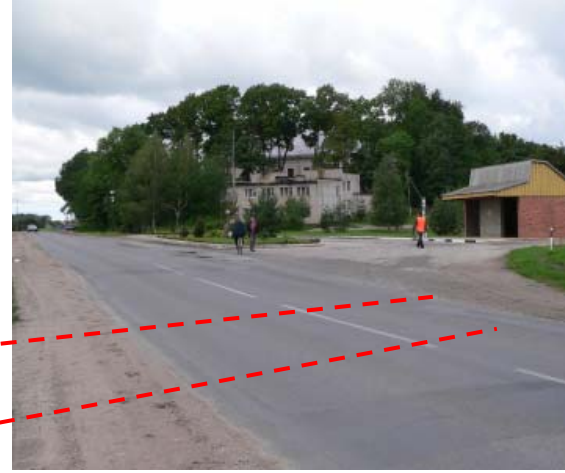
3. An additional pedestrian crossing shall be also planned at a three-arm junction with the local road (3). In a close proximity to the junction the Krosna local administration and a bus-stop are located, thus, this part of the section has an intensive pedestrian traffic to and from the bus-stop (Fig. 1.3.).

Fig. 1.3. Pedestrian crossing at the bus stop behind the building of local administration (3).

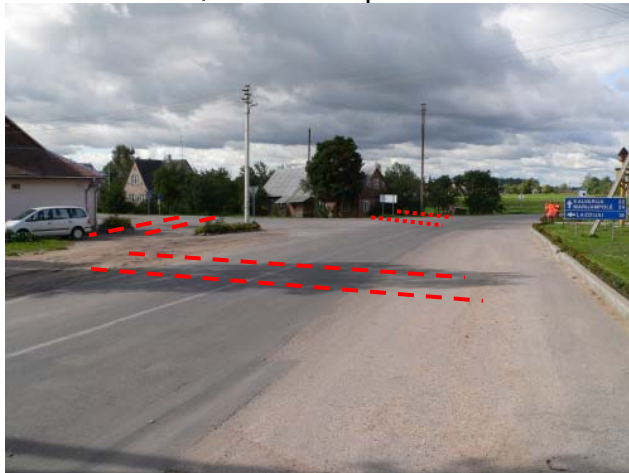
4. The junction of the central part of the village with the road No. 2502 to Lazdijai town could also be used as a speed reduction measure (4). The traffic in this junction has not been organized: a wide junction zone, no pedestrian infrastructure (Fig. 1.4.). This segment of the road could probably have a rather intensive pedestrian traffic due to the public attraction centres situated on both sides of the road: church, shop, etc. When selecting the most suitable scheme for the junction it is necessary to make it especially safe from the point of view of all groups of the road users. Therefore, the most optimal alternative is a compact roundabout.

Fig. 1.4. Additional pedestrian crossings in the junction with the road No. 2502 (4)

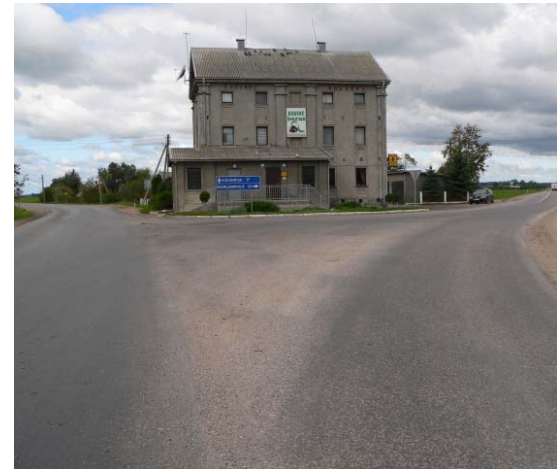
The junction with the road No. 182 (5)

5. A three-arm junction with the national road No. 182 at the end of the Krosna village (5) must be reconstructed (Fig. 1.5.). Dangerous traffic conditions in this junction are caused by the following reasons:

- two national roads intersect at a sharp angle, therefore, the junction could be characterized by the prevailing high speeds;
- due to the closely located buildings the visibility conditions are extremely unfavourable.

Taking into consideration the fact that due to the layout of the buildings there is no possibility of changing the trajectory of the road and it is not possible to improve the visibility without demolishing the buildings, the junction shall be reconstructed into a compact roundabout.

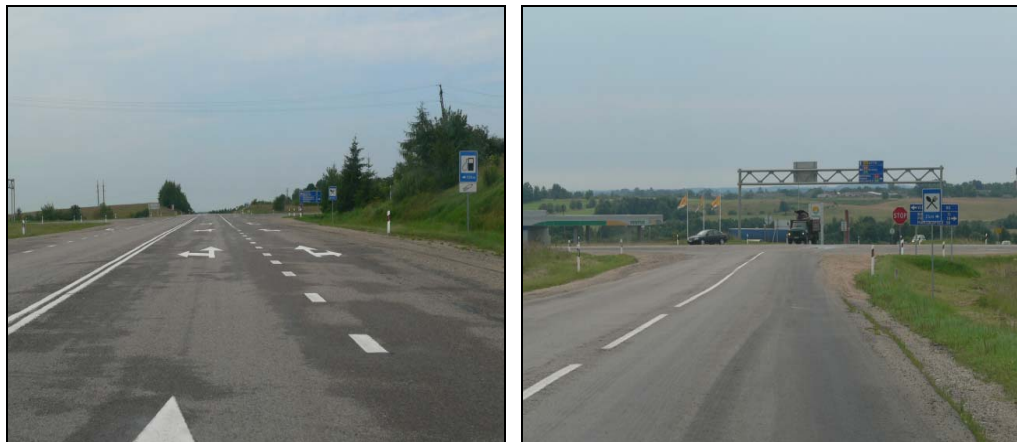
Fig. 2.1. The junction at 79,57 km of the road No. A16 Vilnius-Prienai-Marijampolė

- **Road pavement parameters.** Road pavement within the junction zone is very wide encouraging speeding on the major road and especially dangerous conditions for the vehicles driving from a minor road. Due to a wide carriageway within the junction zone, the drivers are allowed to perform dangerous manoeuvres – U-turns, overtaking from the right.

- **Design of the junction.** Design of the junction allows passing the junction at a high speed in any direction. The junction is provided with acceleration-deceleration lanes which increase a driving comfort but decrease safety.

- **Traffic separation in the junction.** Traffic separation with a horizontal marking is not safe (the left traffic lanes of the major road are used both for the left turn and for going straight).

- **Visibility.** The junction is situated on a hilly terrain, the road No. 129 within the junction zone runs along a slope, therefore the visibility at the junction is insufficient for the drivers. The prevailing high speeds at the junction lead to frequent conflict situations where the junction is entered without noticing the approaching vehicle on a major road;

- **bus-stops within the junction zone.** On the major road No. A16, in front of and behind the junction, bus stops are located. On a high volume road where the speed limit is high the solution to locate a bus stop so close to the carriageway is especially unsafe: pedestrians run on a carriageway trying to get to the bus stop and wait for the bus by standing very close to vehicles passing by at high speeds.

While analysing the existing situation it was determined that the junction must be redesigned. When selecting the most suitable model for the junction one shall take into consideration the distribution of traffic flows, the breakdown of the traffic by different type of vehicles, the needs of all road users. It is also necessary to ensure that the junction is safe from the point of view of all groups of the road users.

It was determined that the junction shall be reconstructed into a roundabout. A roundabout would ensure:

- low speeds within the roundabout zone;
- sufficient capacity;
- sufficiently safe traffic conditions for all groups of the road users.
