VOICE SITES

SPAIN

Better conditions to achieve lower risk for pedestrians in the intersection Plaza España – Av. Reina M^a Cristina in Barcelona

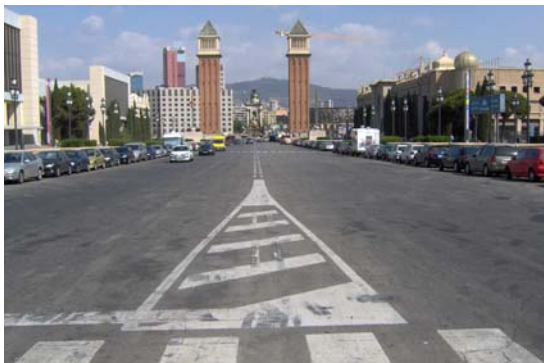
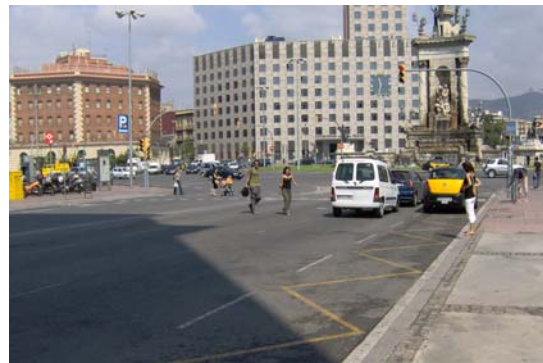
- The carriageway is too large (4 lanes per direction) in a street with low traffic flow. The drivers are tempted to accelerate too much due to impression of long way ahead, largeness and space free of obstacles

- About 5 % of the pedestrians near the pedestrian crossing (controlled by traffic light) pass outside the crossing -towers side- due to existence of walls for the metro exit just in front of pedestrian crossing

- About 20 % of the pedestrians cross outside the signalised pass -Plaza España side- due to the location of the crossing. The itinerary for the pedestrians is not the natural for the pedestrians

- Being a fairly large carriageway, certain groups of pedestrians (elderly citizens) have difficulties to cross with time given in the green phase
- The width of the sidewalk in front of the Venetian towers is too small. It is insufficient for the high number of pedestrians using the pavement, especially during fair and spectacles in the Av. M^a Cristina. The presence of bus and taxi stops make the situation more serious. Additionally the location of the towers will intervene more in the natural itinerary of the pedestrians walking parallel to the carriageway

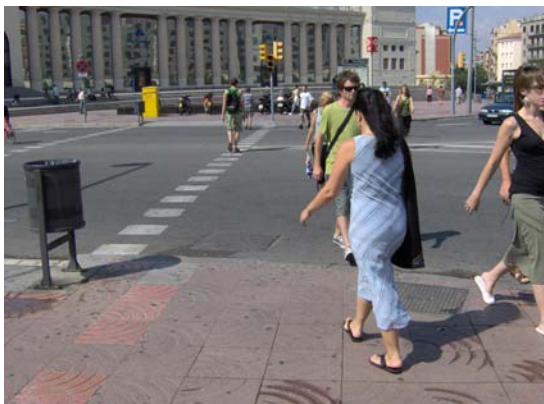
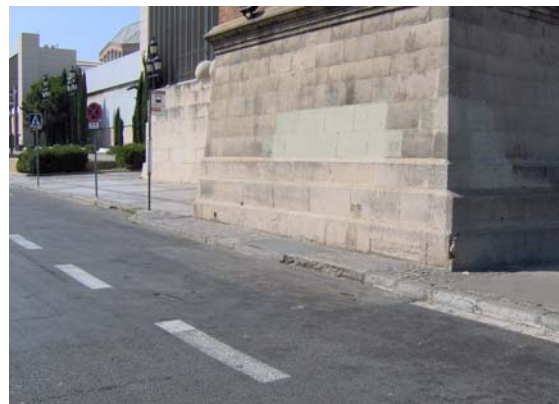
- Construction of a elevated pedestrian crossing just at the entrance for drivers to Av. Reina M^a Cristina, in an area where the number of crossing pedestrians is highest, obliging the drivers to reduce considerably their speed (solution used frequently in local streets in Cataluña). Stretch the carriageway; with 2 lanes per direction plus one for waiting taxi and one for bus. These measures will reduce the drivers speeds and avoid or reduce possible accidents whit crossing pedestrians.

- Channel the pedestrians in their natural itinerary's, enlarging the area for the pedestrian crossing, offering in a crossing area all the natural passes where the pedestrians can cross.

- For the groups of pedestrians with difficulties to cross during the green phase of the light signals, a median of two metres of width is disposed, so that the pedestrian can have a refuge in the case the time for crossing is finished. For the greater events and many pedestrians it is important that the number of metres of kerb is reduced, especially in the middle of the carriageway.

- The sidewalks are projected wider in accordance with the reduction of the carriageway. Passing the Towers, the width shall be doubled and the pedestrians can walk in more comfortable conditions. The bus-stop dispose of a platform with more useful space.
