VOICE SITES

CZECH REPUBLIC

Treatment of four high-risk sites in Český Krumlov

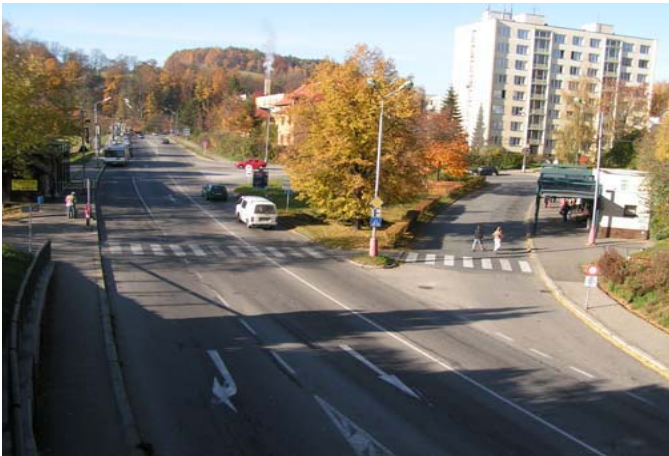
1. Intersection Špičák, 12.0-12.3 km, present condition:

- intersection of main road I/39 and country road Tř. Míru
- enormous distance between branches and intersection
- absence of zebra crossings on the branches
- absence of separate turning lanes
- intensive bus traffic flow
- two bus stops

- new shape of intersection – small roundabout facilitating bus traffic
- redesigning central zones, parking lanes
- modification of bus stops design
- non-barrier divided zebra crossings for pedestrians

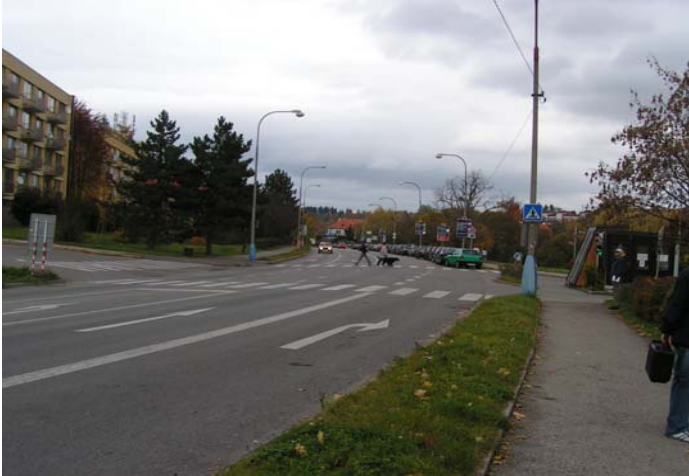
2. Intersection Jelenka, 12.3-12.4 km, present condition:

- intersection on the main road I/39 and the country road
- enormous distance between branches and the intersection
- enormous length of zebra crossings with no protection for pedestrians

- shortening the crossing distance
- creating sidewalk cap, divided islands
- redesigning central zones

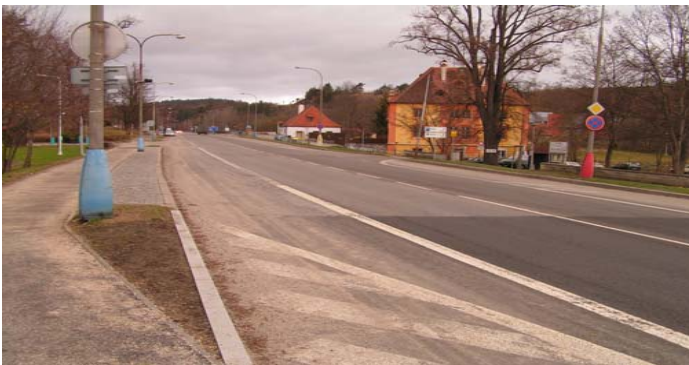
3. I.sektor, 12.4-12.9 km, present condition:

- long straight distance, two bridges
- enormous width of lanes
- outstanding curb parking
- large area of road markings

- new parking lanes, relocating zebra crossings and bus stops
- reducing the lanes' width, changes to the entries to country roads

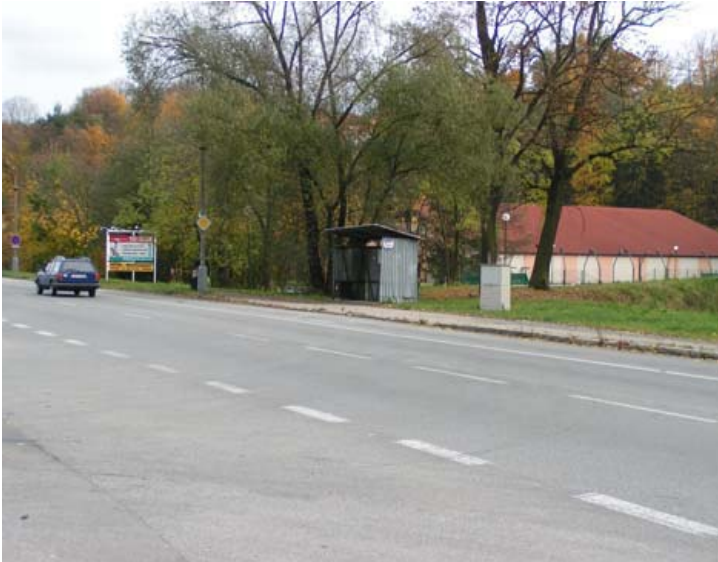
4. Intersection Chvalšinská x Fialková, 12.9 – 13.1 km, present condition:

- 4-branches intersection, width of road I/39

- bad range of vision, unclear zebra crossings
- bad location of bus stops

- creating a small roundabout,
- creating non-barrier divided zebra crossings for pedestrians
- ensuring safer left-turn flow from minor branch
- creating infrastructure installations for deceleration of cars speed on entry ways to the city
