„Intersecting Safely”

An International Student Competition
to improve the safety of vulnerable road users
at urban intersections

The conception of improvement of vulnerable road users safety at the section of Grochowska Street in Warsaw

Team PG-02
Agata Chmielewska
a.chmielewska@wp.pl
Aleksandra Mulawa
olamola@wp.pl

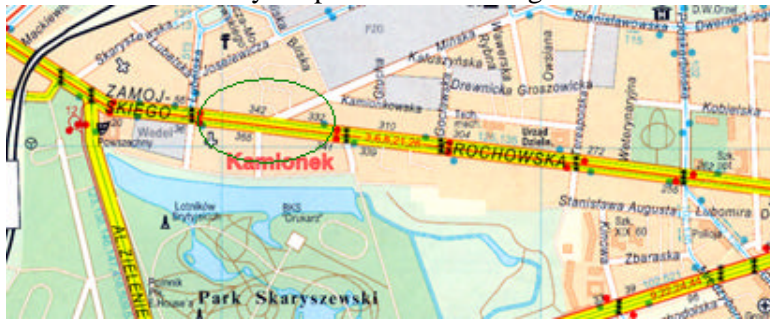
Fig. 1. The location of analysed pedestrian crossing at Grochowska Street in Warsaw.

A very dangerous and onerous for traffic participants, pedestrian crossing in Warsaw at Grochowska Street by the property no. 355 (fig.1) was selected to the International Student Competition to improve the safety of vulnerable road users at urban intersections organised by the European Transport Safety Council in cooperation with the Motor Transport Institute in Warsaw.

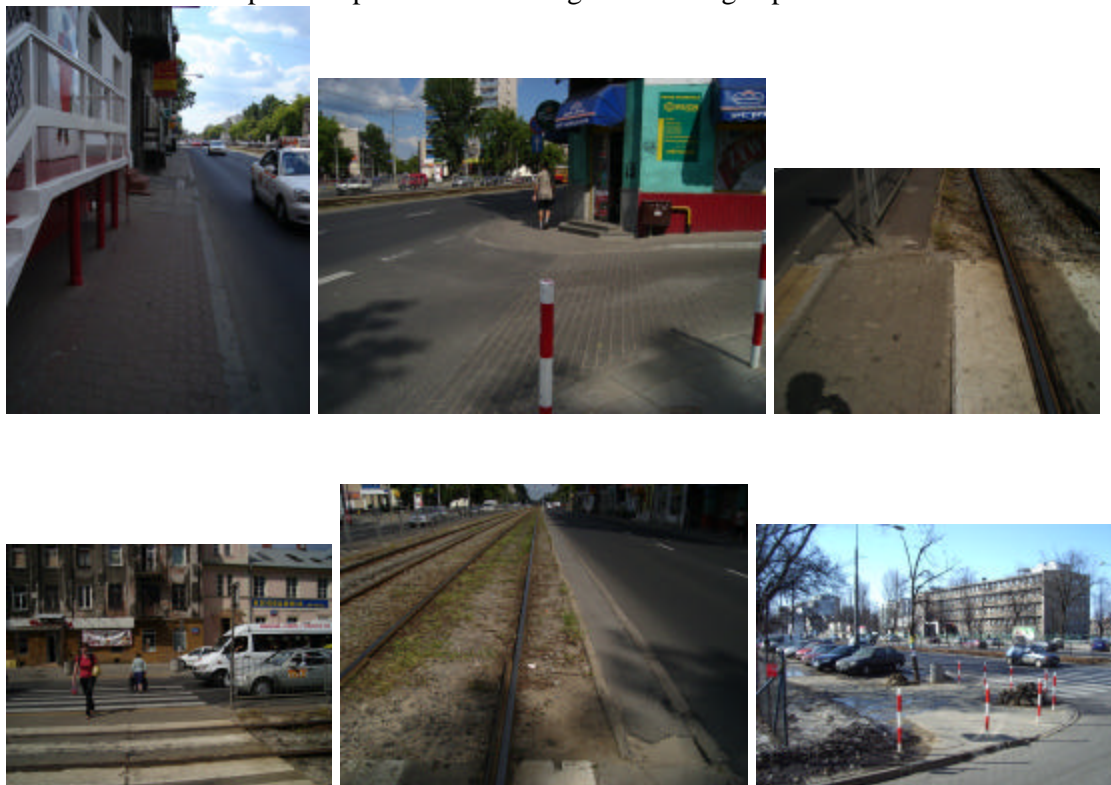
Fig. 3. Photographic documentation

The research and local visions confirm that the visibility from the right side of roadway, both for pedestrian and vehicle is poor because of a car park located along the edge of the right turn lane into Lubelska Street. A pedestrian walking along right roadway is forced to use a narrow pavement and to look out for the steps of nearby buildings. The passengers who get off the tram on Zamoyskiego Street side shorten their route by tramline zone in the direction of pedestrian crossings at Grochowska Street which causes the risk of accident. From the left roadway side, the visibility of pedestrian crossing for vehicles heading to Minska Street is insufficient. The excessive speed of vehicles – there are the periods when the additional obstacle for a pedestrian is exceeded speed amounting even to 90 km/h (2% of drivers) and exceeded speed limit of 50 km/h by over 50% of drivers. The vehicles from the left roadway coming from the east fail to respect acceleration lane from Minska Street and use the lane closed to traffic. That also makes crossing Grochowska Street difficult. The cars travelling from Minska Street pass the pedestrian crossing with too high speed

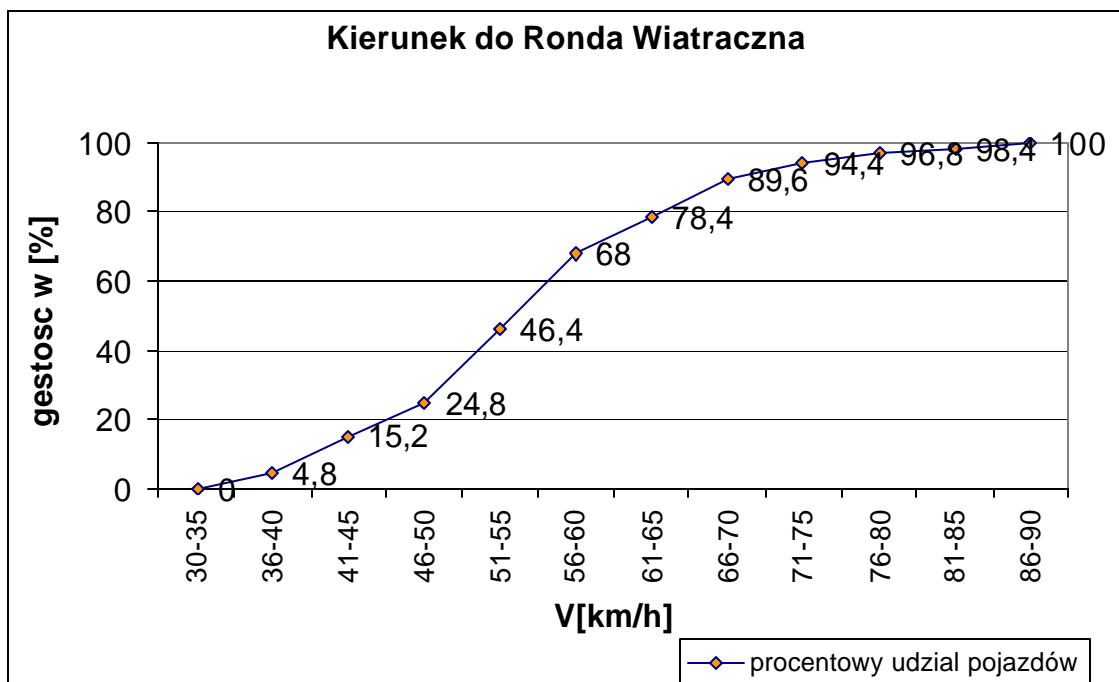
Percentage speed distribution

Distribution function

Fig. 5 The distribution and speed distributions at Grochowska Street in the proximity of analysed pedestrian crossing

On the basis of wheeled and pedestrian traffic measurements it was stated that there is high volume of motor vehicle (almost 4000 v/h in both directions in the area of pedestrian crossing) and tram traffic (38 trams per hour) at Grochowska Street and that the pedestrians have great difficulty getting through the pedestrian crossing safely (fig. 4). Speed measurements conducted with radar speed indicators in proximity of analysed pedestrian crossing in both directions show (fig. 5), that more than 60 % of drivers in the direction of Wiatraczna Roundabout and 40 % of the drivers in the direction of Zieleniecka Street exceed speed limit (50 km/h).

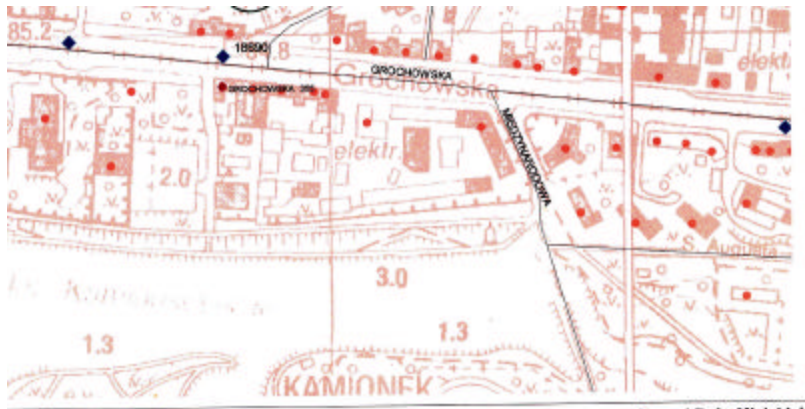
MAPA WYPADKÓW
Rok 2003
ul. Grochowska 355

MAPA WYPADKÓW
Rok 2004
ul. Grochowska 355

MAPA WYPADKÓW
Rok 2005 (bez aktualizacji grudnia)
ul. Grochowska 355, 357

Fig. 6 Accidents location (according to data from MZD in Warsaw)

Exceeding speed limit and lack of safe distance between vehicles are the main causes of accidents at Grochowska Street. In 99% of accidents the inhabitants of the area are both perpetrators and victims.
