PLACE OF INTEREST – historical town Český krumlov

Task 2

Topic – DIRECTION OF ROAD 1/39 THROUGH THE TOWN

TASK 1

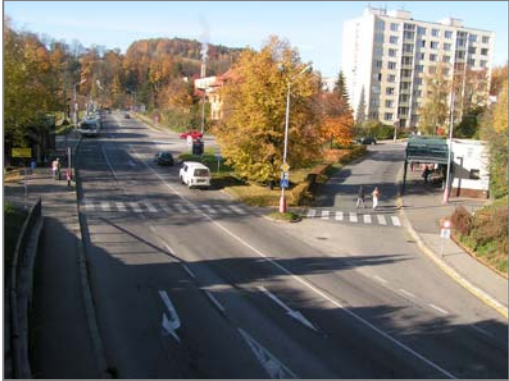
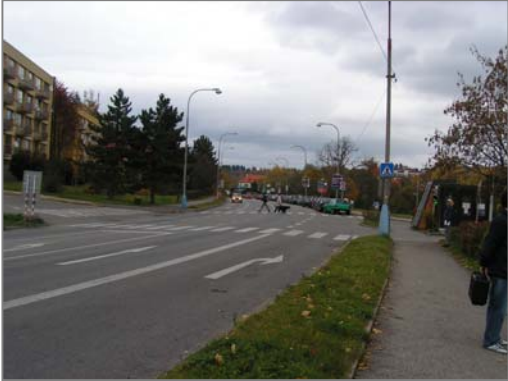
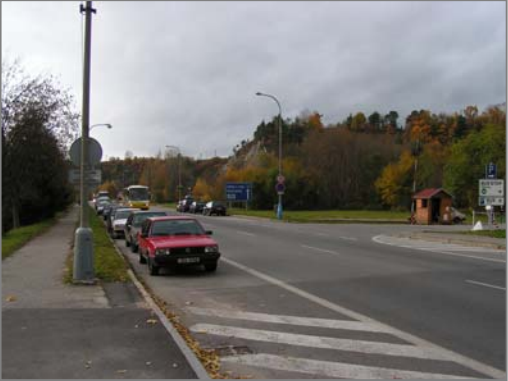
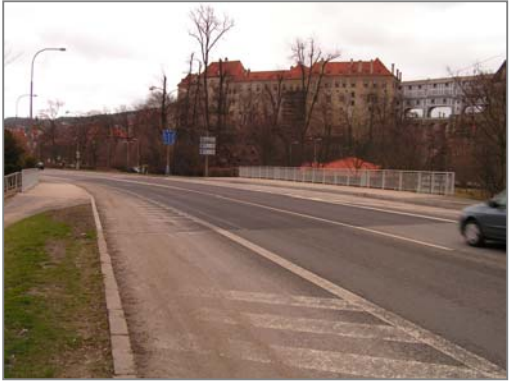
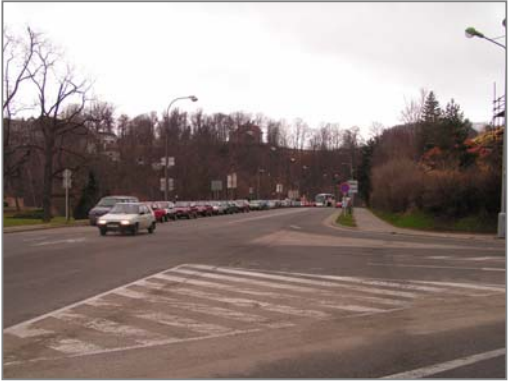
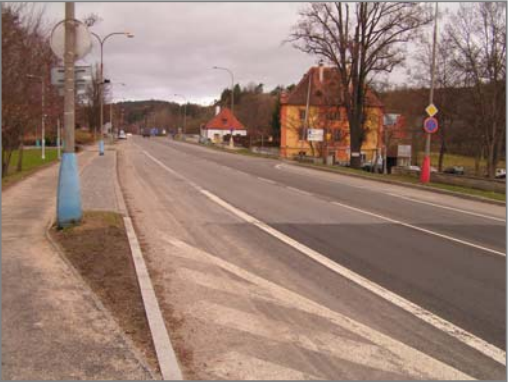
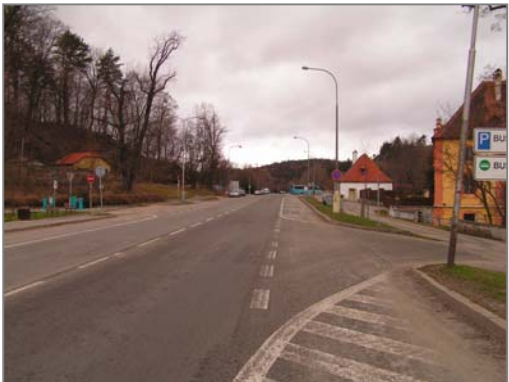
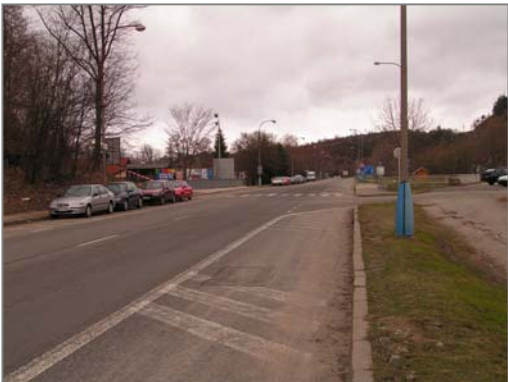
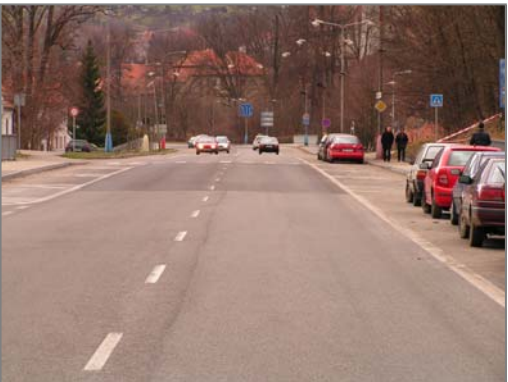
PHOTOGALLERY:

Main traffic shortage

- Enormous width of road profile
- High speed of car
- High accident frequency in the whole section
- Absence of zebra crossings
- Outstanding problems with curb-parking

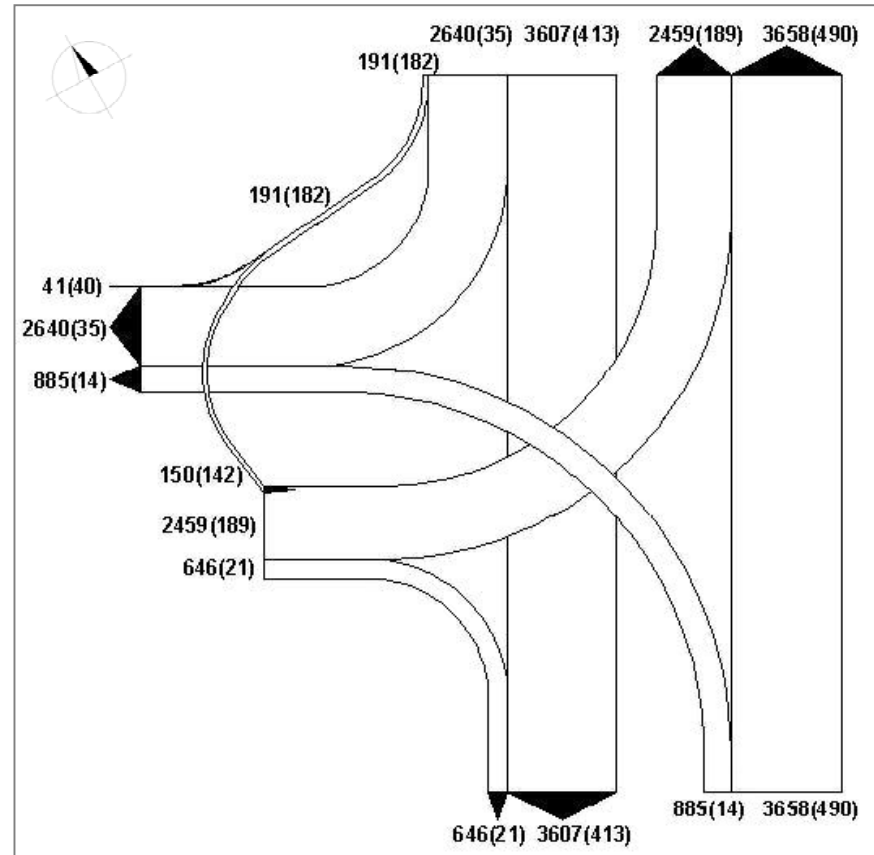
TRAFFIC FLOWS

- measuring in the year 2004
- xx (xx) – intensity of cars per 24 hours (number of heavy cars per 24 hours)

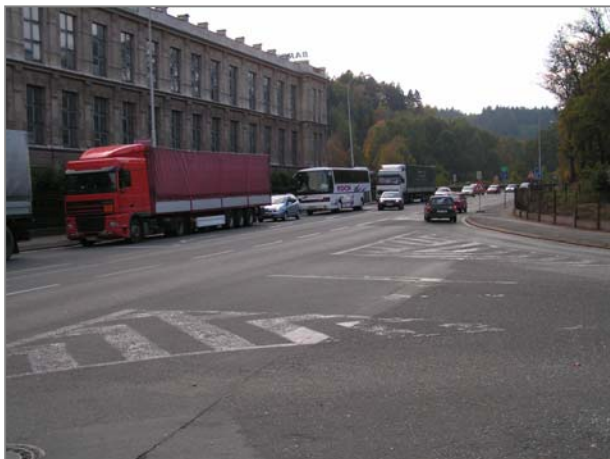
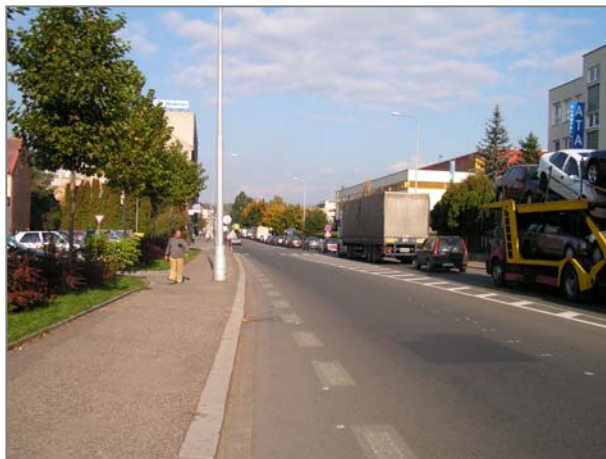
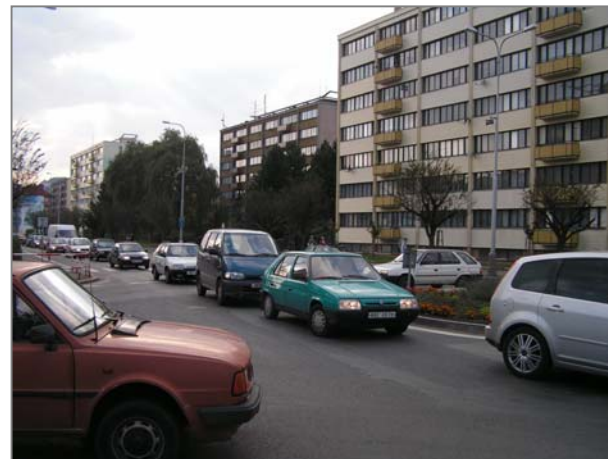
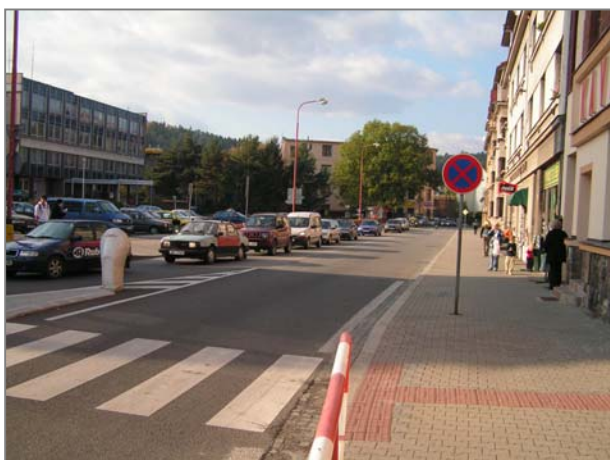
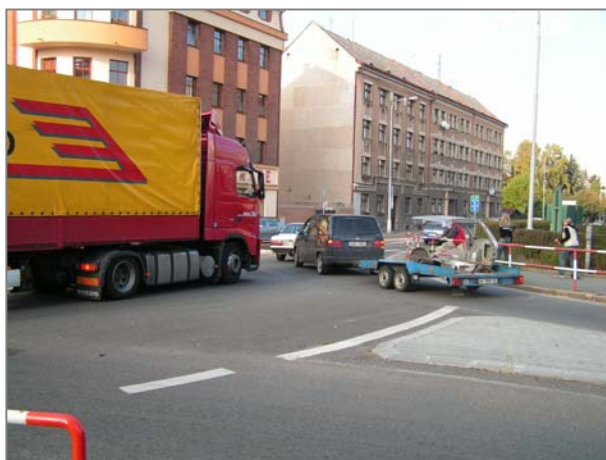
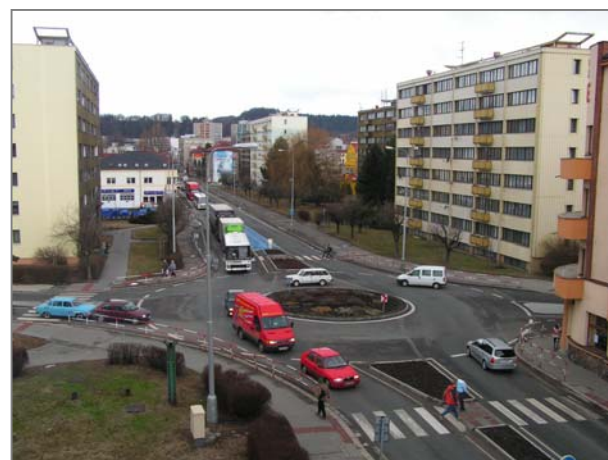
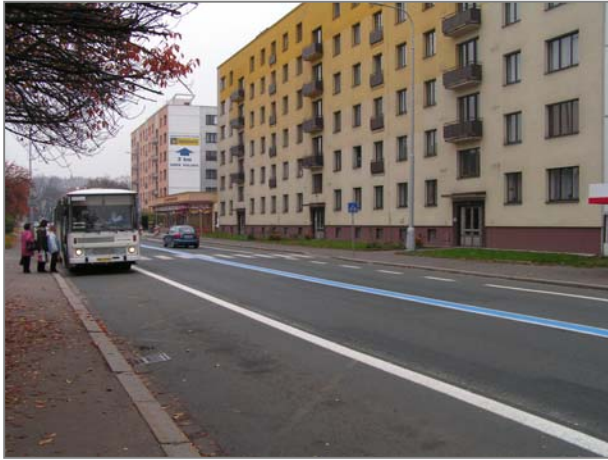
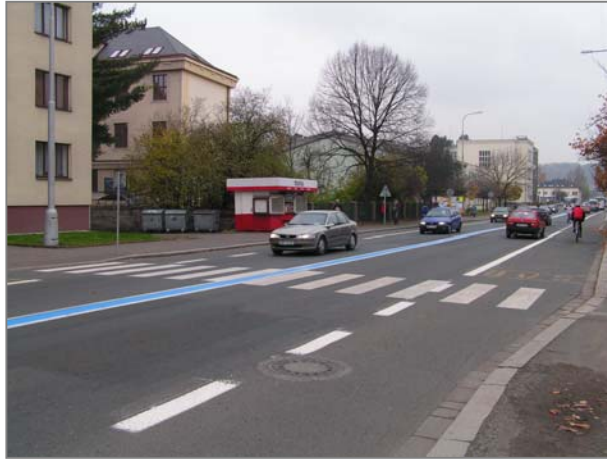
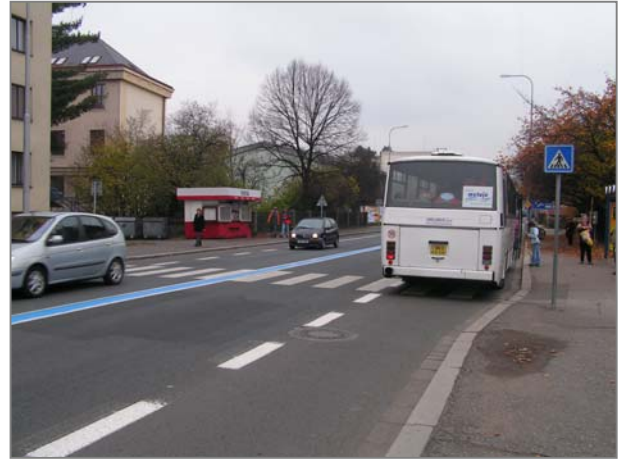
Photogallery

Traffic problems:

- high intensity of cars (22 000 car by 24 hours on I/33)
- high number of heavy trucks
- enormous width of road profile
- traffic jams (several kilometers long que of cars in the centre of the city)
- dangerous pedestrian crossing near the bus stops
- wide lane on roundabout – high speed on roundabout's lane
