## **„Intersecting Safely”**

An International Student Competition  
to improve the safety of vulnerable road users  
at urban intersections

## **The conception of improvement of vulnerable road users safety at the section of Grochowska Street in Warsaw**

Team PG-03

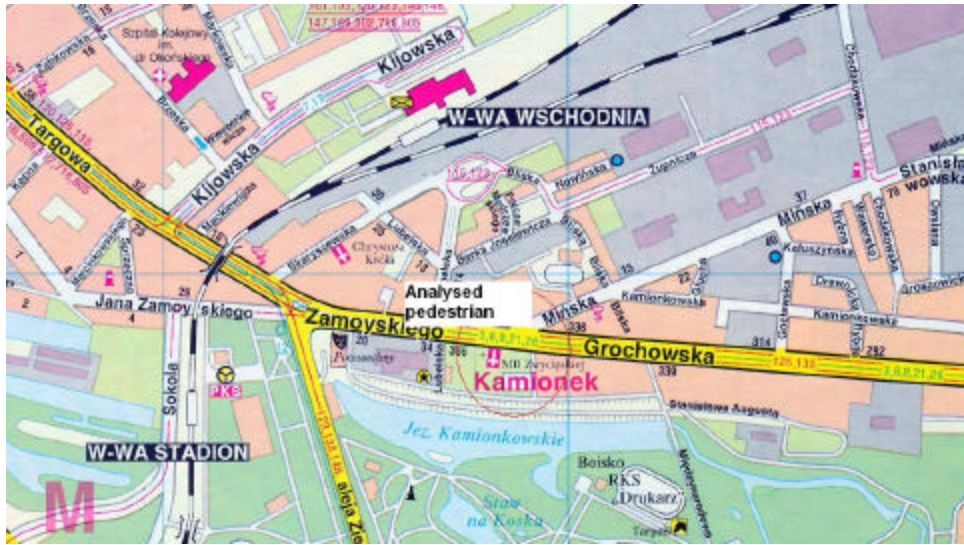
Fig. 1. The location of analysed pedestrian crossing at Grochowska Street in Warsaw.

A very dangerous and onerous for traffic participants, pedestrian crossing in Warsaw at Grochowska Street by the property no. 355 (fig.1) was selected to the International Student Competition to improve the safety of vulnerable road users at urban intersections organised by the European Transport Safety Council in cooperation with the Motor Transport Institute in Warsaw.

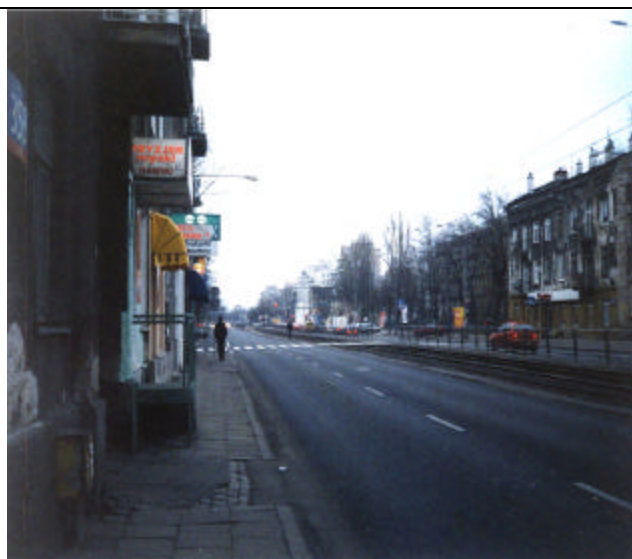
To small width of pavement in the direction of Wiatraczna Roundabout

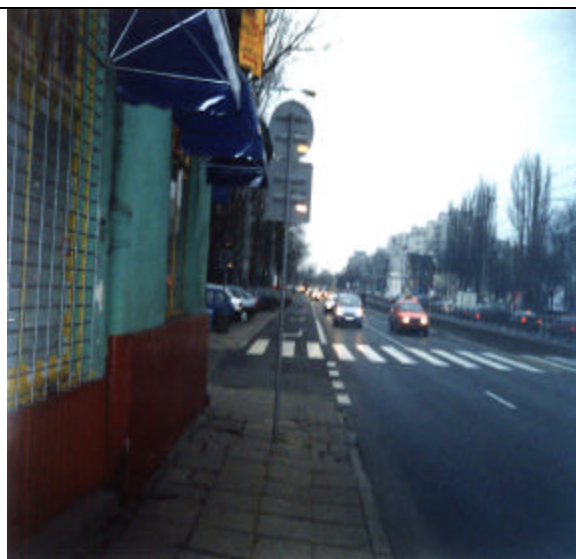
Pedestrian crossing in the direction of Wiatraczna Roundabout

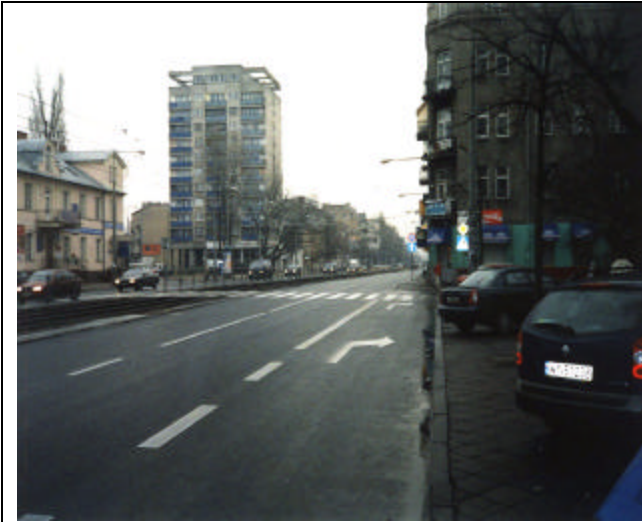
Pedestrian crossing In the direction of Zieloniecka Street

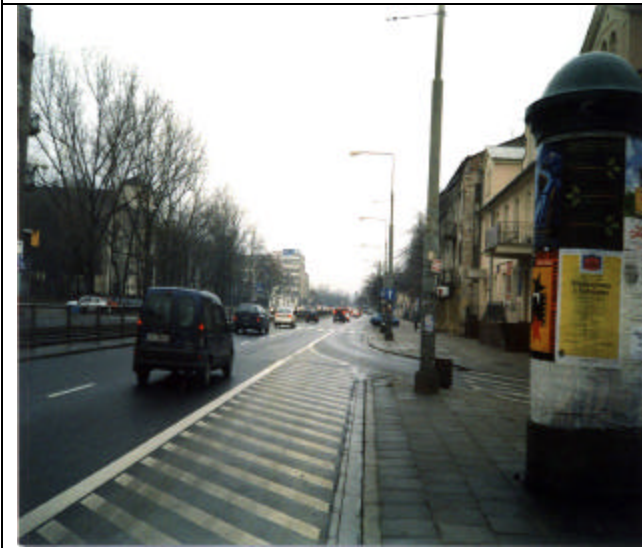
Junction Grochowska-Minska

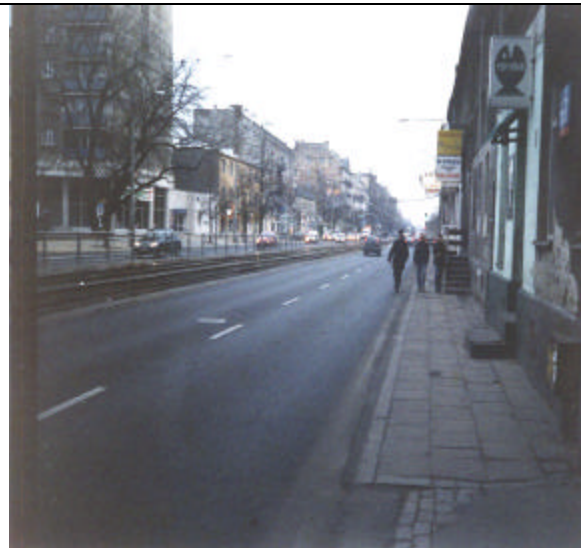
Small width of pavement on the Grochowska Street

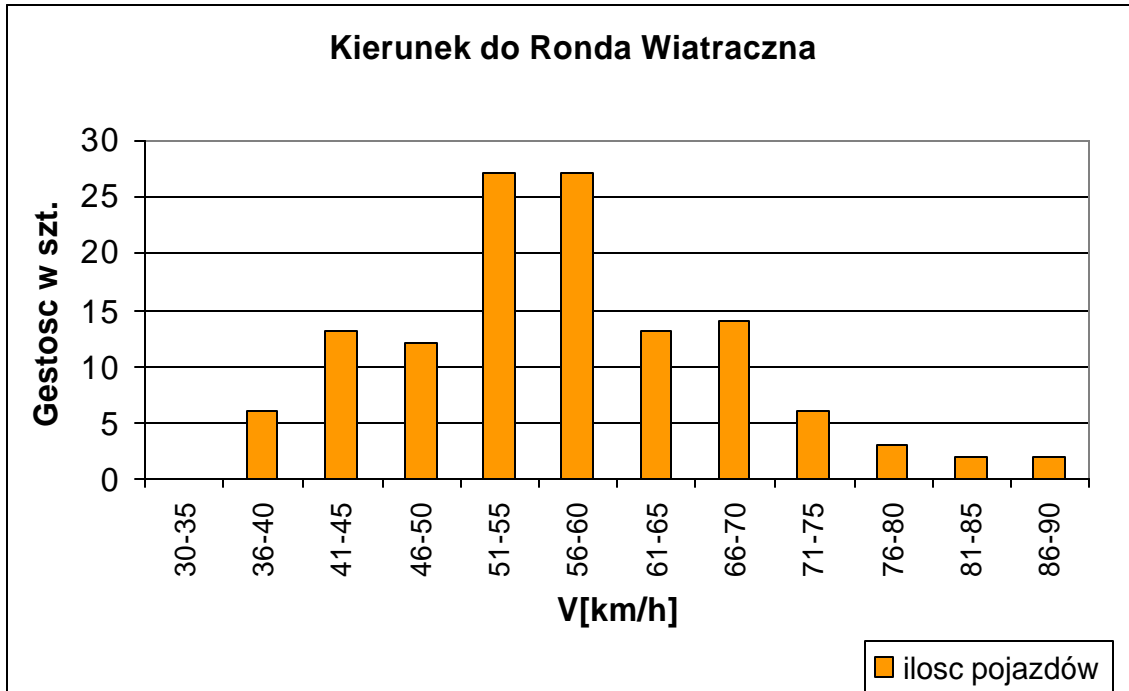
Fig. 5 The distribution and speed distributants at Grochowska Street in the proximity of analysed pedestrian crossing

### Percentage speed distribution

### Distribution function

**Percentage speed distribution**

**Distribution function**

On the basis of wheeled and pedestrian traffic measurements it was stated that there is high volume of motor vehicle (almost 3000 v/h in both directions in the area of pedestrian crossing) and tram traffic (38 trams per hour) at Grochowska Street and that the pedestrians have great difficulty getting through the pedestrian crossing safely (fig. 4). Speed measurements conducted with radar speed indicators in both directions show (fig. 5), that average speed in the direction of Wiatraczna Roundabout amounts to 57 km/h, and over 60 % of drivers exceed speed limit during a day (50 km/h), in the direction of Zieleniecka Street the average speed amounts to 48 km/h, and over 40 % exceed speed limit during a day (50 km/h).

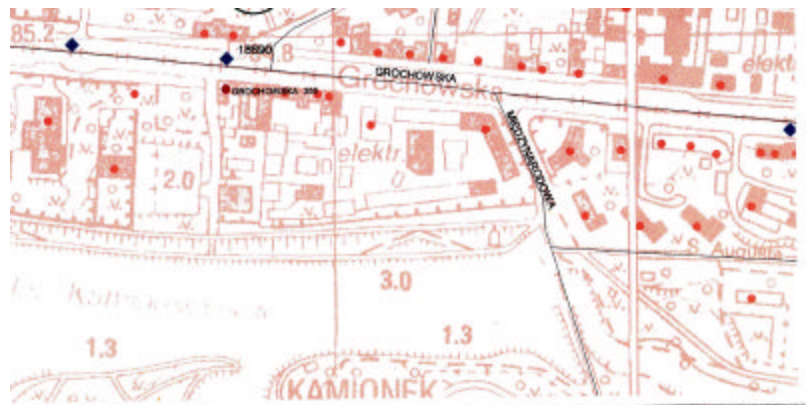
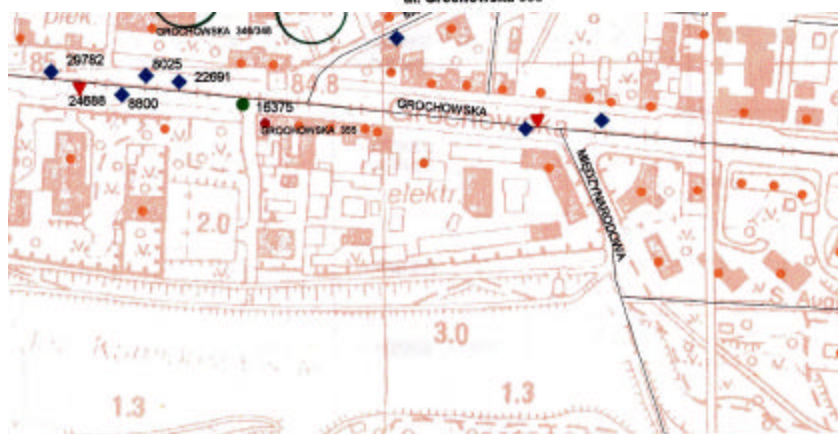
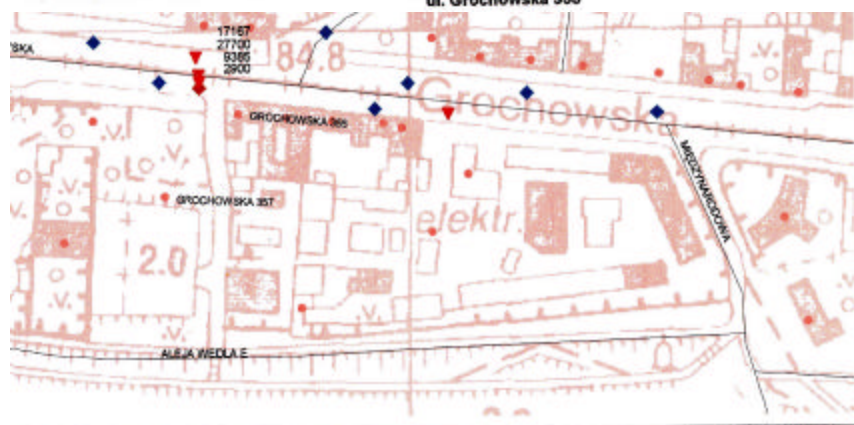
Fig. 6 Accidents location (according to data from MZD in Warsaw)

MAPA WYPADKÓW  
Rok 2003  
ul. Grochowska 355

MAPA WYPADKÓW  
Rok 2004  
ul. Grochowska 355

MAPA WYPADKÓW  
Rok 2005 (bez aktualizacji grudnia)  
ul. Grochowska 355, 357

Collisions with pedestrians  
Running into pedestrian without fatalities  
Running into pedestrians with fatalities  
Other accidents without fatalities  
Other accidents with fatalities  
Collisions
