**Vulnerable road user
Organisations In
Cooperation across Europe**

**TRAFFIC SAFETY IMPROVEMENT IN THE AREA OF
GROCHOWSKA AND MIŃSKA STREET CROSSROAD
with the special attention to unprotected transport system users**

Student's team from the Civil Engineering Faculty of Warsaw University of Technology

Warsaw, August 2006

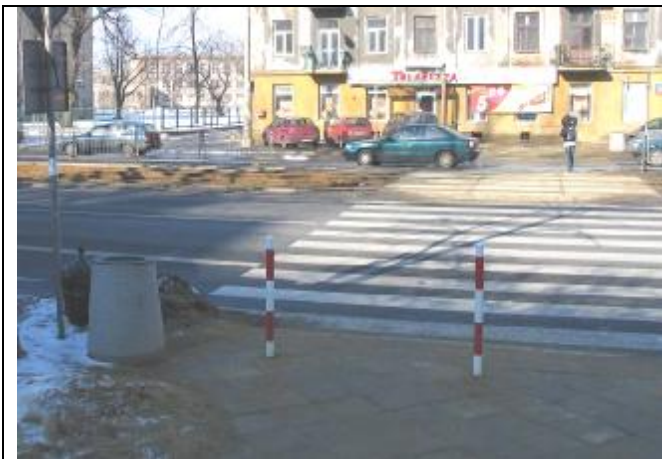
Fot. 1. Grochowska st. – view on the pedestrian crossing without traffic lights.

In the area of analysed crossroad a pedestrian crossing through both roadways of Grochowska street (and tram line) is situated. The crossing is not equipped with traffic lights. No pedestrian refuges together with huge car traffic intensity as well as intensive tram traffic creates many traffic safety problems. Moreover, narrow pavements along Grochowska street (esp. on the south side of the street) and disorganized car parking, reduces pedestrian's safety especially due to imposing visibility.

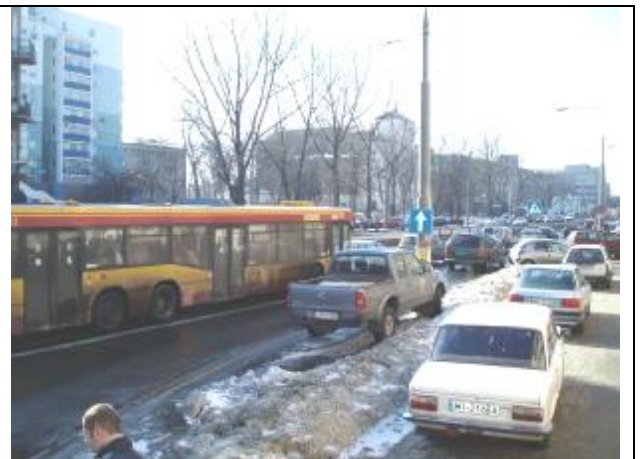
Fot. 2. Grochowska st.. View on the pedestrian crossing not visible because of cars parked closely to the crossing.

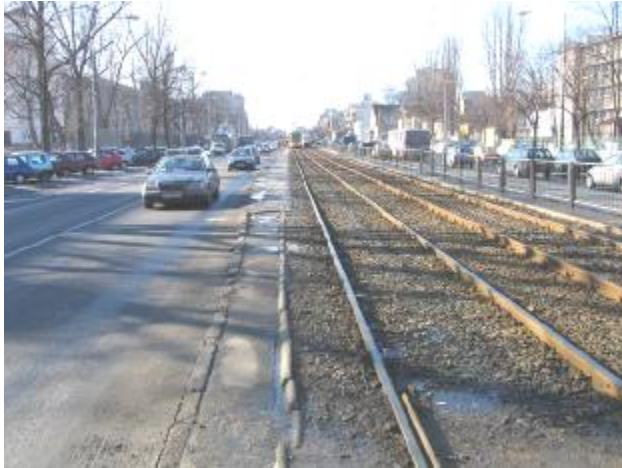
Fot. 3. Grochowska st. – tram track situated in roadway division belt – without refuge for pedestrians crossing the street.

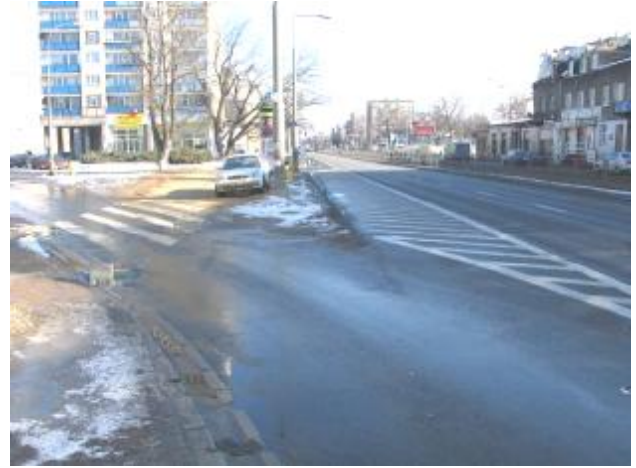
Fot. 4 Inlet of Mińska st. - unfavourable angle of intersection (approx. 30⁰). Visible pedestrian crossing with isle for pedestrians (car parked) and area excluded of the traffic on Grochowska st..

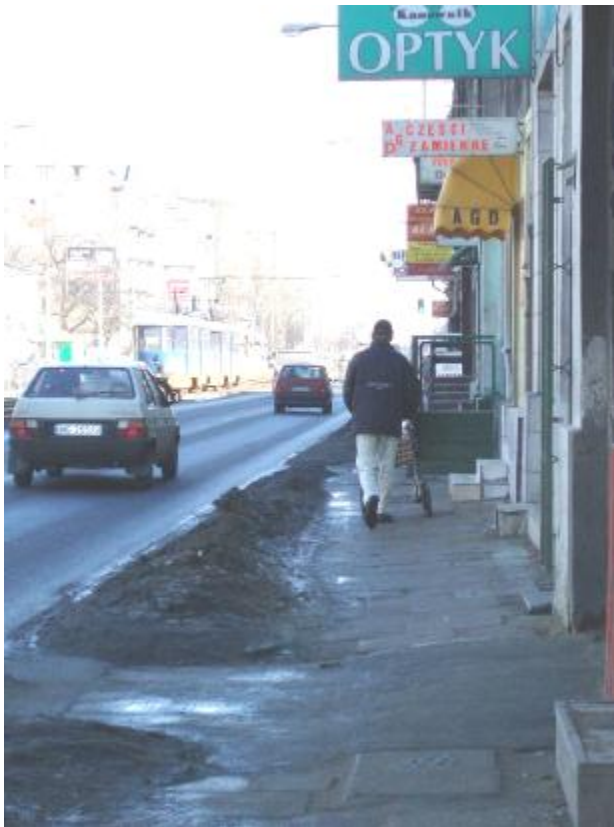
Fot. 5. Grochowska st. – narrow sidewalk on the south side of the street with additional limitations – stairs to shops.

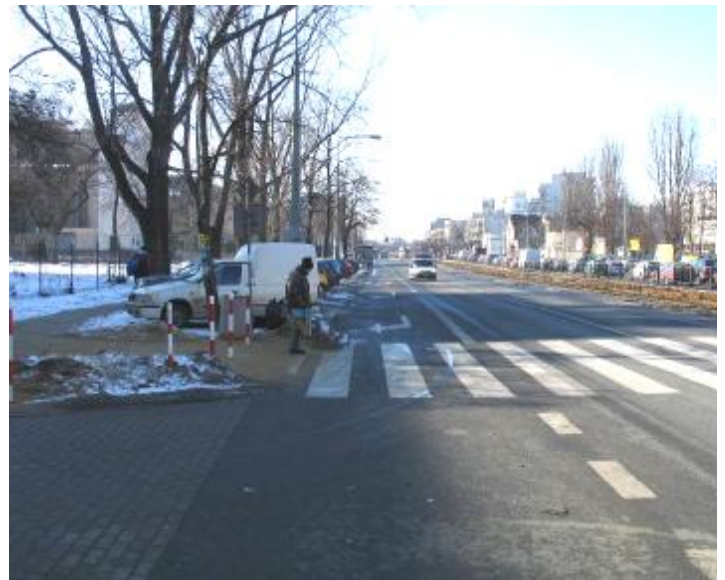
Fot. 6. Grochowska st. – intersection with acces road to esteta Kamionek (near to pedestrian crossing).

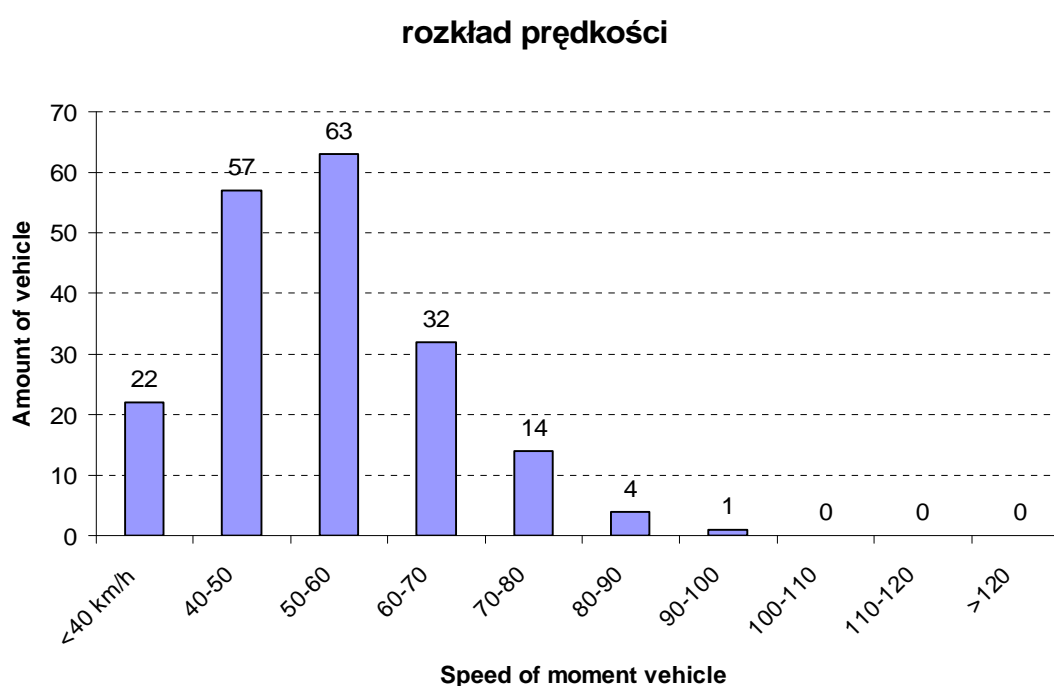
Measurements of instant velocities were made on the April 22th, between 10.30 and 11.30. survey were done on Saturday in order to find conditions that incline vehicles' drivers to drive with higher speed (without traffic clutter that is typical for working days). Measurements were made on both roadways of Grochowska street; each time before the side of pedestrian crossing analyzed in the project. Spewed of 193 vehicles were registered.

Results of measurements indicates that no significant problems connected with speed exceeding were identified.

Approximately 84% of vehicles were moving slower than 60 km/h.

Fig. 4.4 Instant velocity distribution of vehicles moving along Grochowska Street in the neighbourhood of pedestrian crossing.

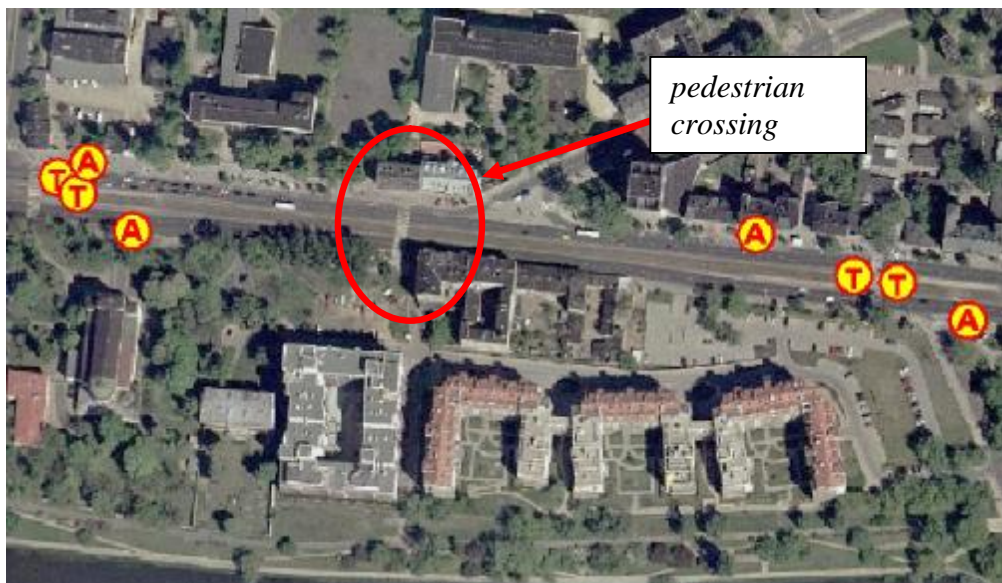
Public transport stops are placed 500 m far from crossroads of Grochowska and Mińska streets. Four stops (2 bus and 2 tram) close to Lubelska Street are located west to the analysed crossroad. Four stops (2 bus, 2 tram) are located near Bliska street - east to the analysed crossroad.

Fig. 4.5 PT stops along Grochowska street

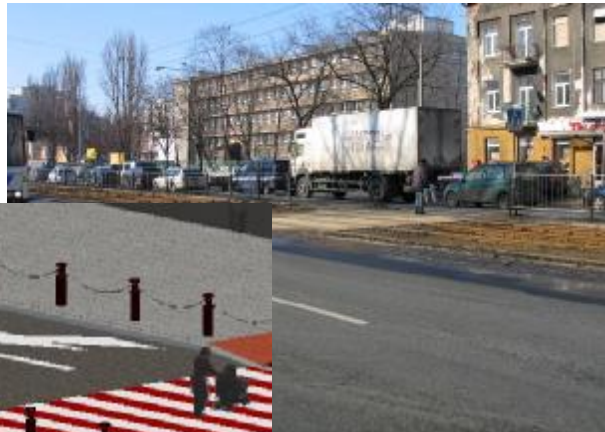
Widen pedestrian refuge on the north and south side of the tramway along Grochowska Street and narrowed traffic lanes at southern and northern Grochowska Street roadlane.

Fig. 5.1 Pedestrian crossing by Grochowska Street- state existing.

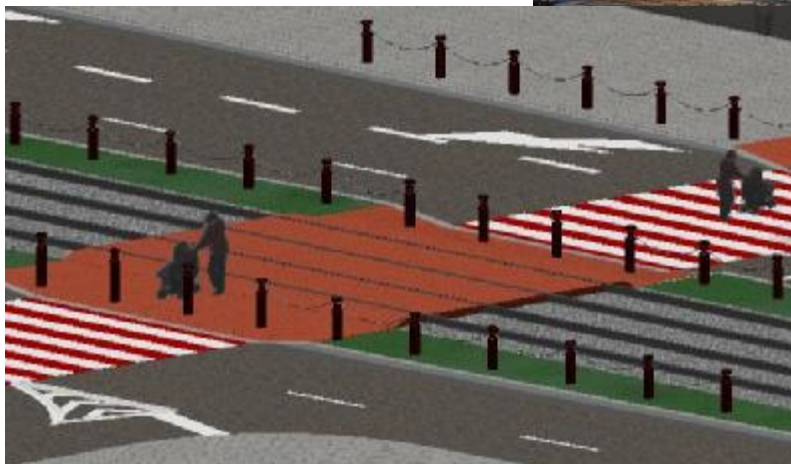
Fig. 5.2 Pedestrian crossing by Grochowska Street- state design.

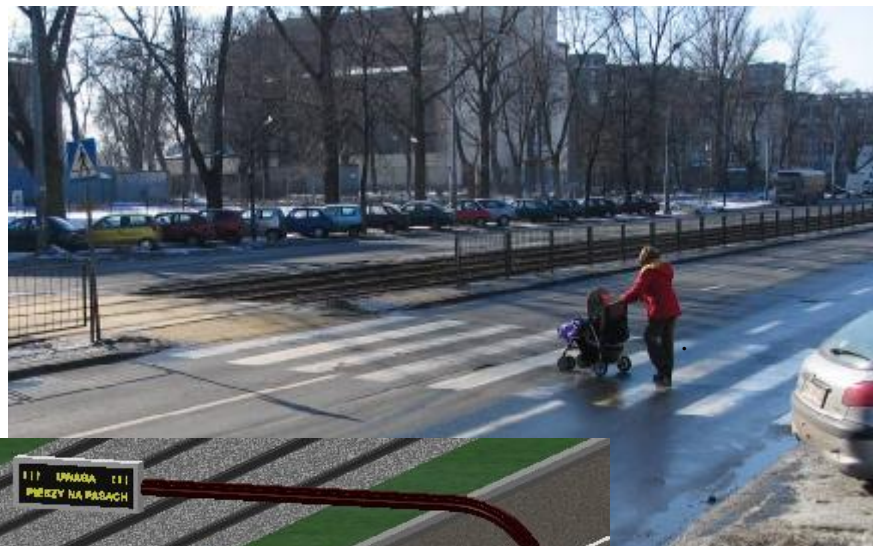
Fig. 5.4 Pedestrian crossing by Grochowska Street- state existing.

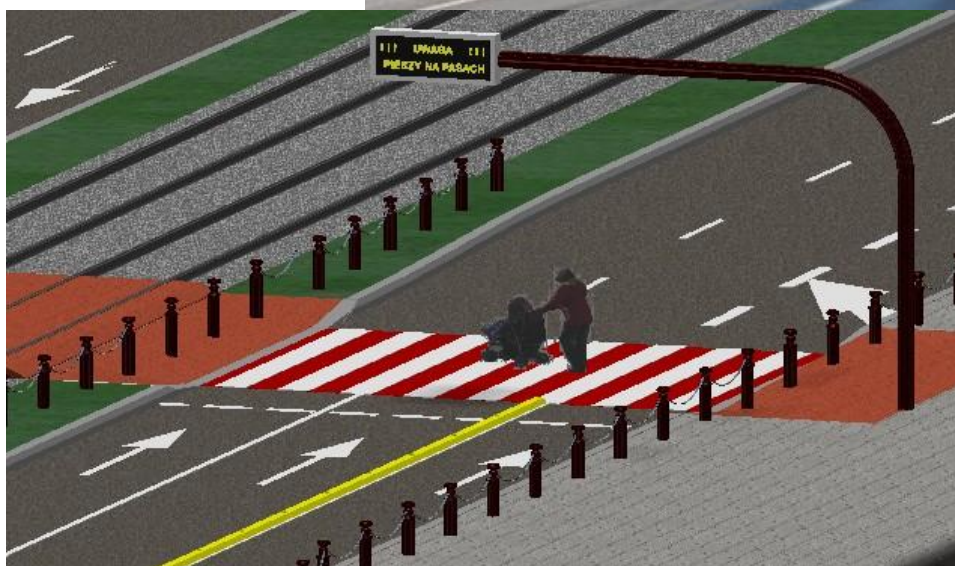
Street over marking, variable message sign together with motion detector mounted on the cantilever jib. Information displayed on sign:

„!!! UWAGA PIESZY NA PASACH !!!”
(!!! PEDESRTRIAN ON ZEBRA CROSSING !!!)

Fig. 5.5 Pedestrian crossing by Grochowska Street- state design.

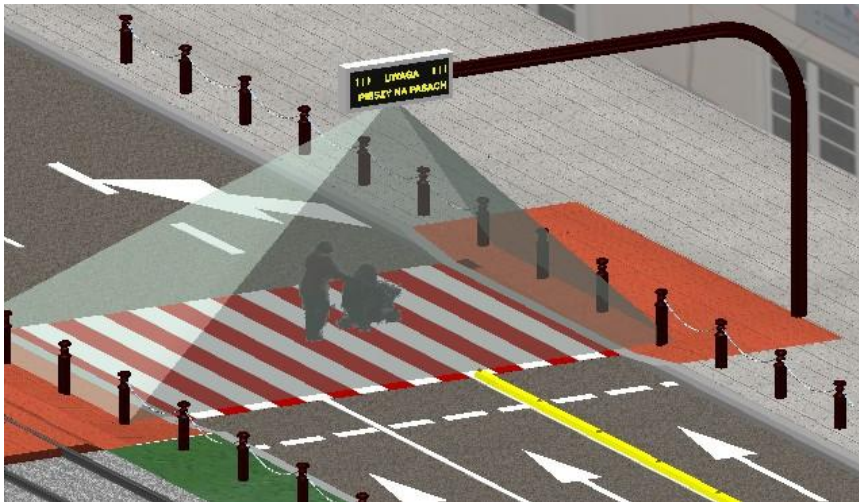
Fig. 5.6 Surface monitored by scanner - state design.

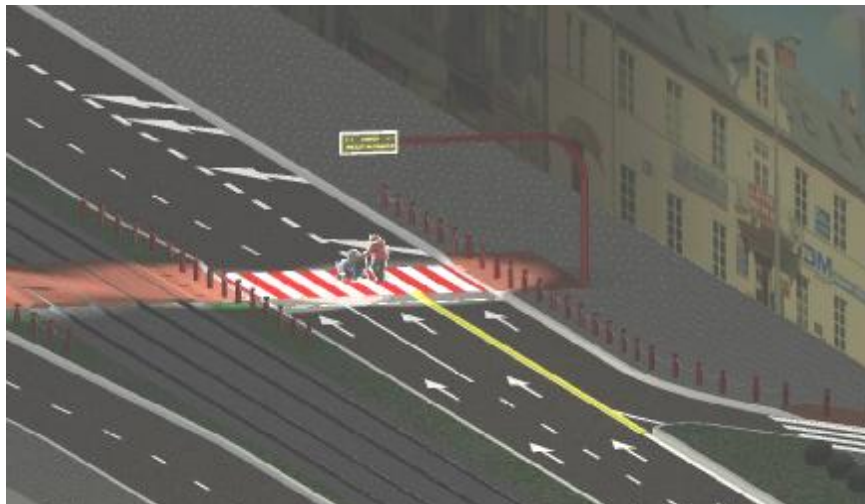
Extra lighting mounted on the cantilever jib.

Fig. 5.7 Illumination of pedestrian crossing.

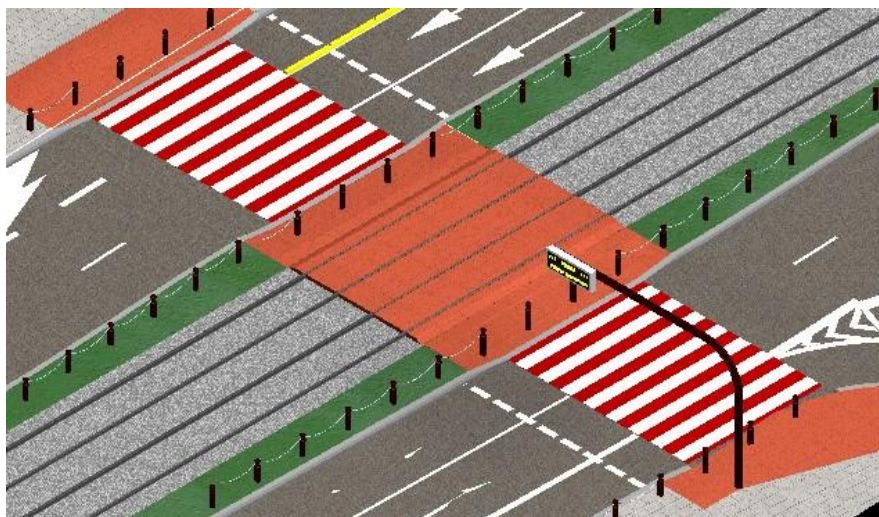
Red coloured pedestrian crossing

Fig. 5.8 Red coloured pedestrian crossing - state design.

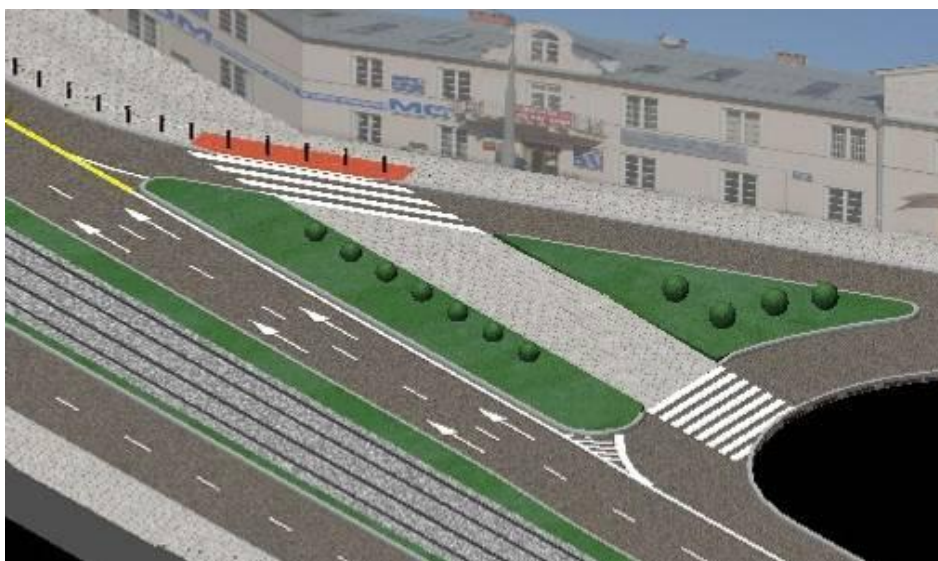
Installing of Flower boxes.

Fig.5.10 Developing of area within pedestrian refuge.
