BETTER CONDITIONS TO ACHIEVE LOW
RISK FOR PEDESTRIANS IN THE
INTERSECTION PLAZA ESPAÑA – AV
REINA M^a CRISTINA IN BARCELONA

Intersecting safely (International Student Competition)

Author: Jose M^a Ortiz Nava
National coordinator: Ole Thorson
Country: Spain
Date: August 2006

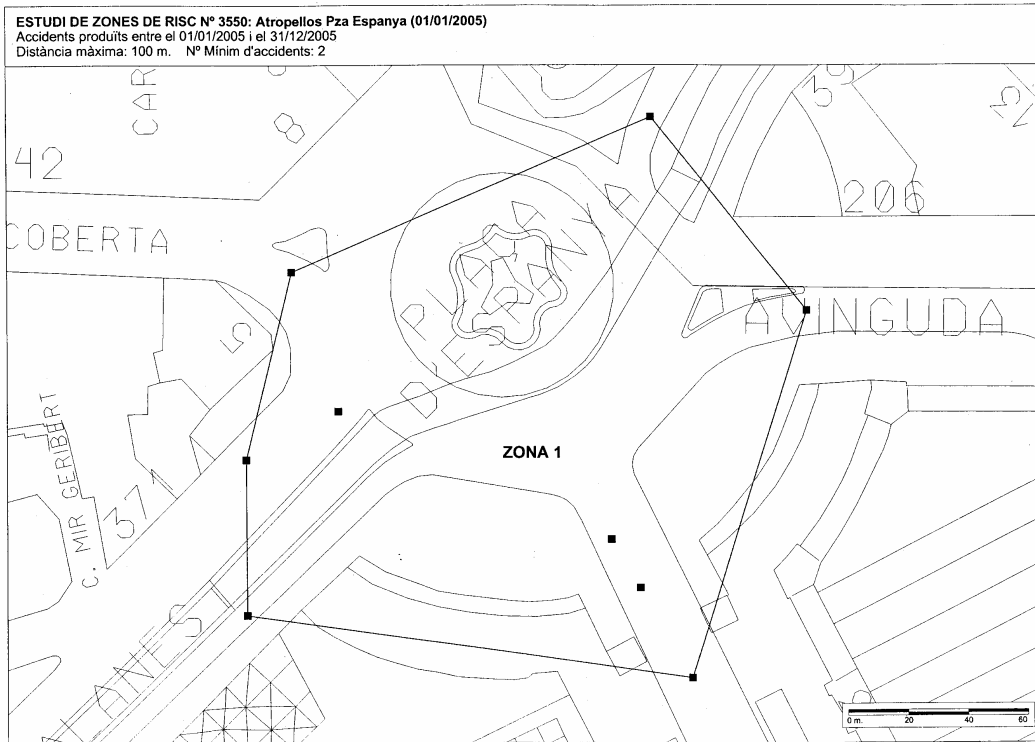
Fig. 1. Pedestrian accidents in 2005

To start the work contact was made with the Barcelona Municipality (Mobility Department) and the municipal Police. Information on the traffic accidents in 2005 in the Plaza España area, especially with pedestrian injury, was provided by the police. It was found that in and round the pedestrian crossing of Av. Reina M^a Cristina near to Plaza España, a pedestrian risk area emerged (Fig. 1).

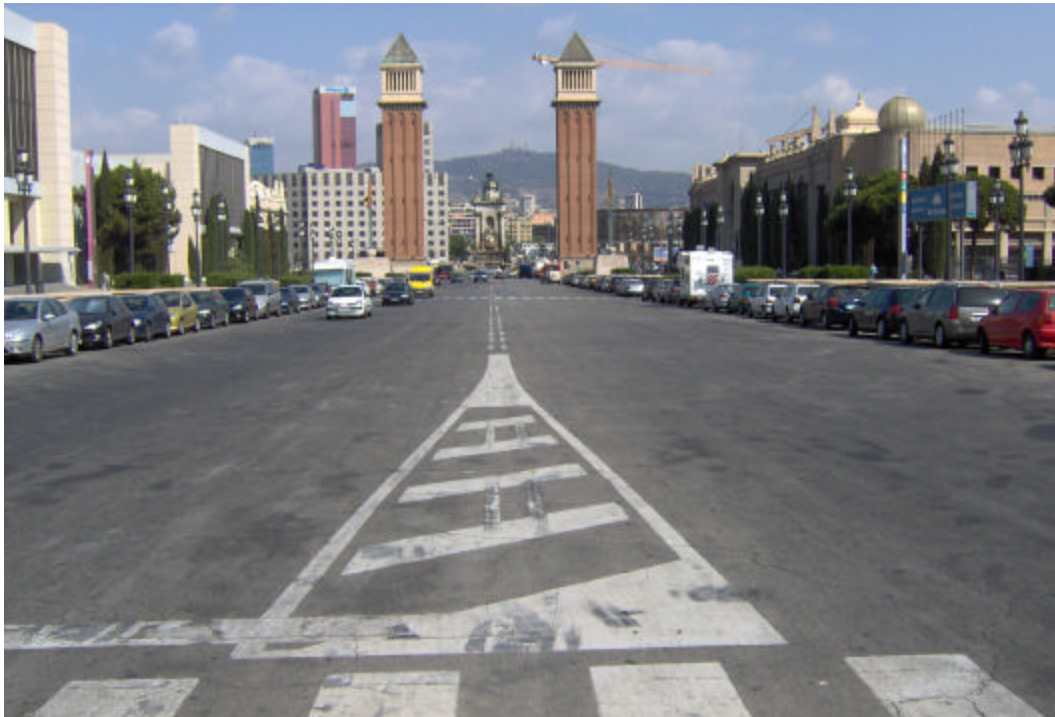
Fig. 2. Av. Reina Maria Cristina view (Plaza España at the bottom)

- The carriageway is too large (4 lanes per direction) in a street with low traffic flow. The drivers are tempted to accelerate to too high speed due to impression of long way ahead, largeness and space free of obstacles (Fig. 2)

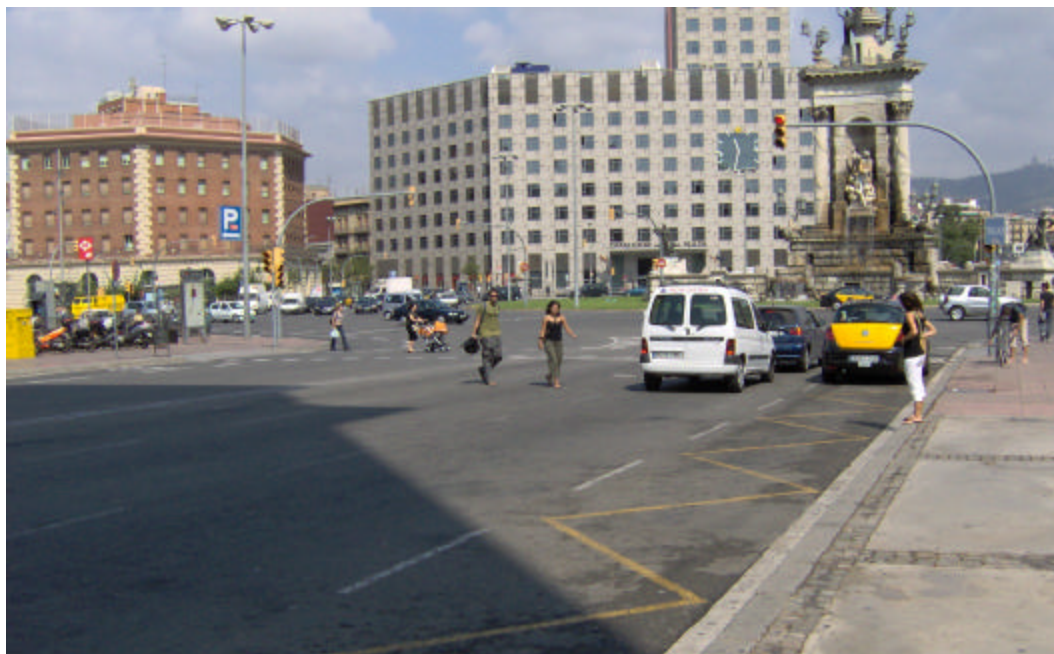
Fig. 3. Pass outside the pedestrian crossing (Venecian towers side)

- About 5 % of the pedestrians near the pedestrian crossing (controlled by light signal) pass outside the crossing -towers side- due to existence of walls for the metro exit just in front of pedestrian crossing (Fig. 3)

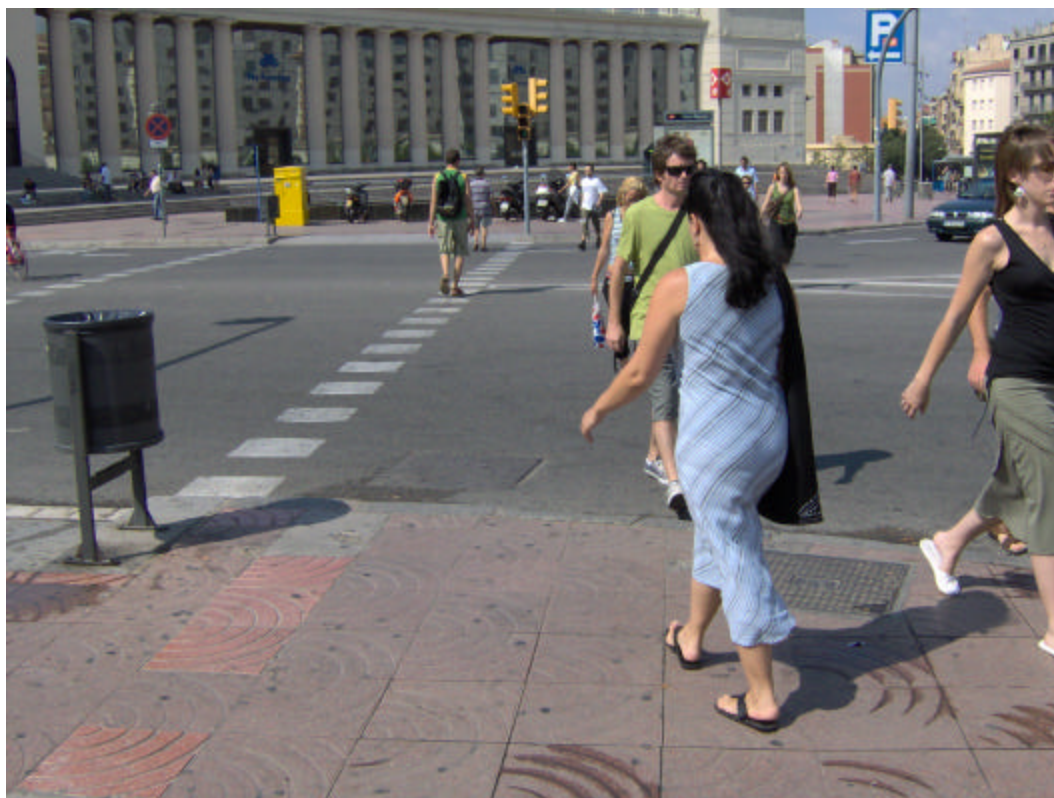
Fig. 4. Pass outside the pedestrian crossing (Plaza España side)

- About 20 % of the pedestrians cross outside the signalised pass -Plaza España side- due to the location of the crossing. The itinerary for the pedestrians is not the natural for the pedestrians (Fig. 4).

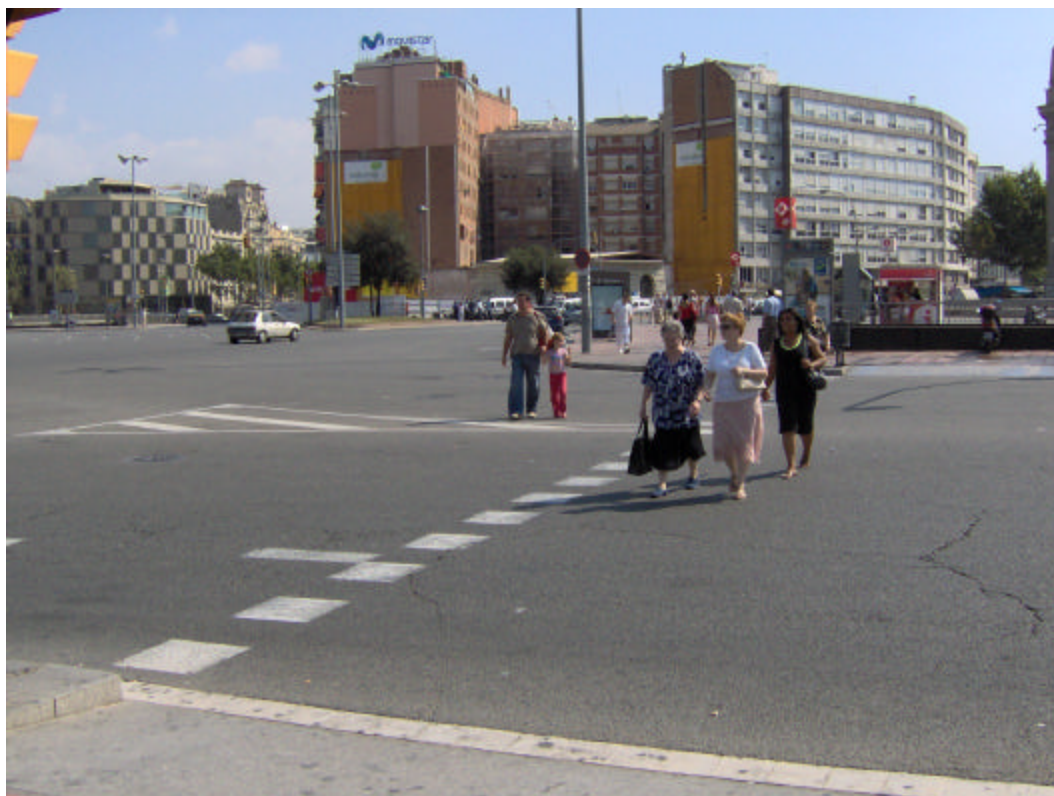
Fig. 5. Elderly citizens and children crossing slowly

- Being the carriageway fairly large, certain groups of pedestrians (elderly citizens) have difficulties to cross with time given in the green phase (Fig. 5).

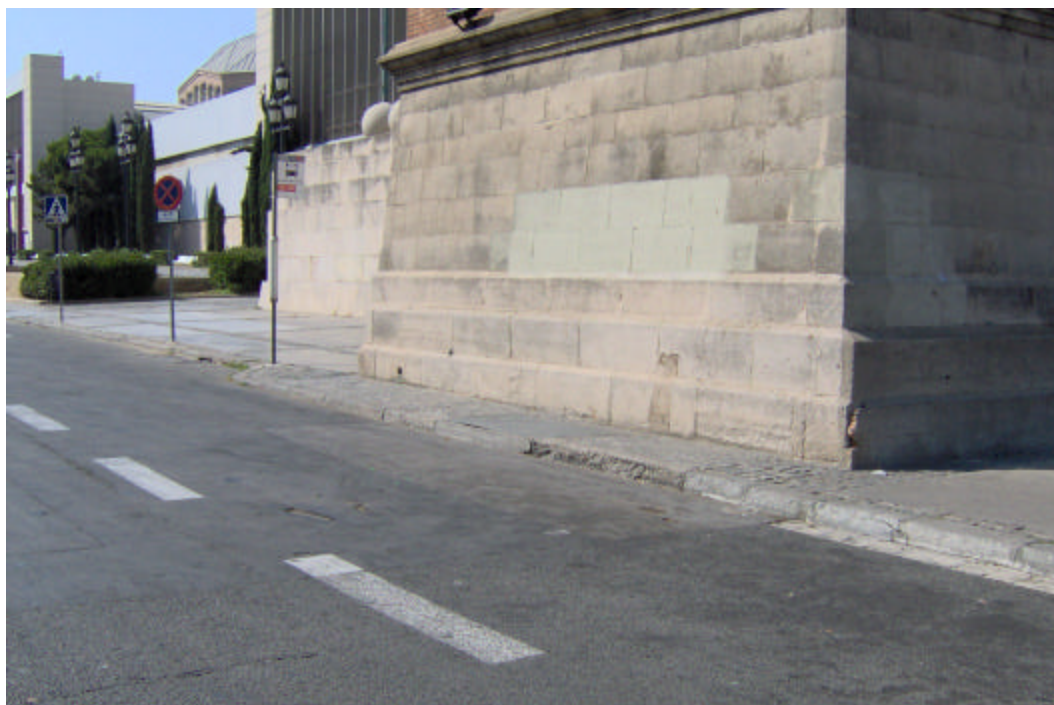
Fig. 6. Width too small of the sidewalk in front of the Venecian towers

- The width of the sidewalk in front of the Venecian towers is too small. It is insufficient for the high number of pedestrians using the pavement, especially during fair and spectacles in the Av. M^a Cristina. The presence of bus and taxi stops make the situation more serious. Additionally the location of the towers will intervene more in the natural itinerary of the pedestrians walking parallel to the carriageway (Fig. 6).

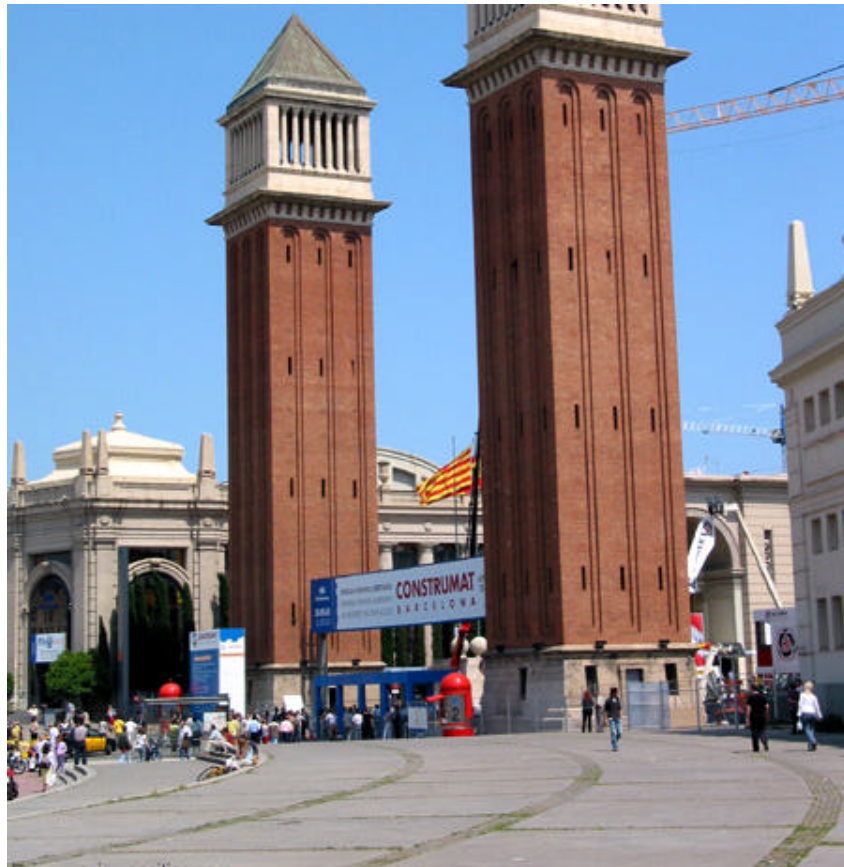
Fig. 7. Event in Av. Reina Maria Cristina

- It is a designed for the circulation of cars and, really, it is a zone with majority of pedestrian use. Not only for the major daily volumes of pedestrians, but also due to the grand number of social events organised in the area and during which car traffic is restricted. (events of piro-light-music, fairs, demonstrations etc.). With these events with thousands of pedestrians obstacles in kerb or central carriageway will disturb (Fig. 7)

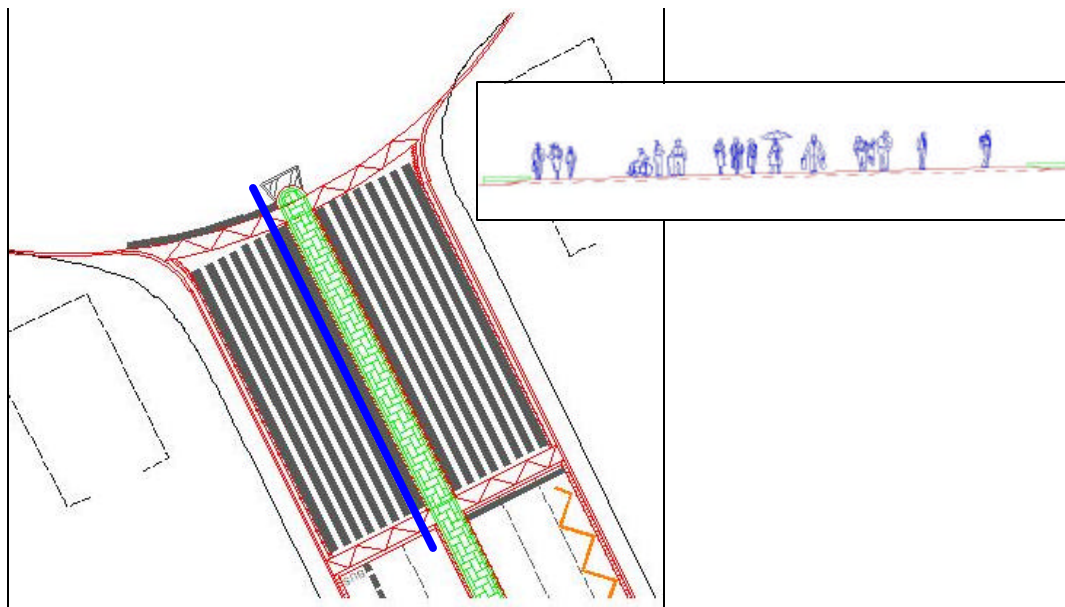
Fig. 8. Longitudinal section of the elevated pedestrian crossing

- Construction of a elevated pedestrian crossing just at the entrance for drivers to Av. Reina M^a Cristina, in an area where the number of crossing pedestrians is highest, obliging the drivers to reduce considerably their speed (solution used

frequently in local streets in Cataluña). Stretch the carriageway; with 2 lanes per direction plus one for waiting taxi and one for bus. These measures will reduce the drivers speeds and avoid or reduce possible accidents whit crossing pedestrians (F ig. 8).

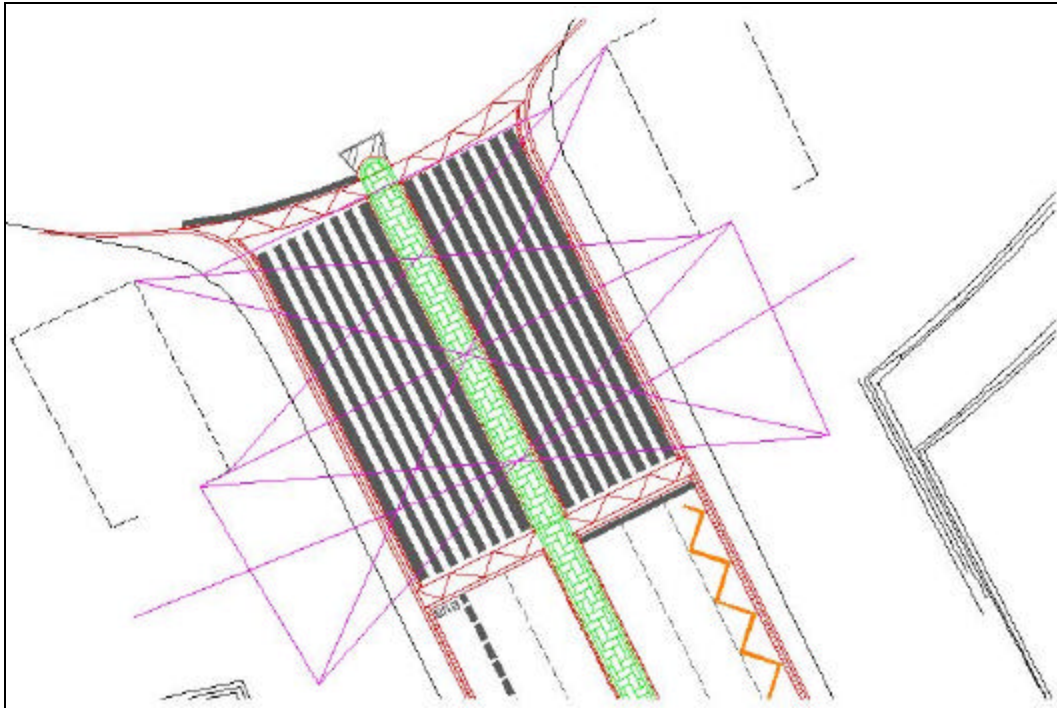
Fig. 9. Natural itineraries of the pedestrians

- Channel the pedestrians in their natural itinerary's, enlarging the area for the pedestrian crossing, offering in a crossing area all the natural passes where the pedestrians can cross (Fig. 9).

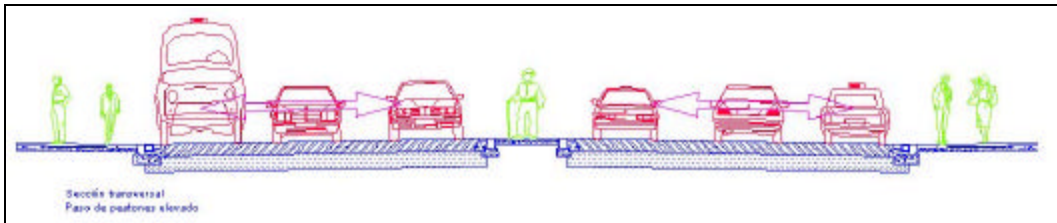
Fig. 10. Transversal section of the elevated pedestrian crossing

- For the groups of pedestrians with difficulties to cross during the green phase of the light signals, a median of two metres of width is disposed, so that the pedestrian can have a refuge in the case the time for crossing is finished (Fig.10). For the greater events and many pedestrians it is important that the number of metres of kerb is reduced, especially in the middle of the carriageway.

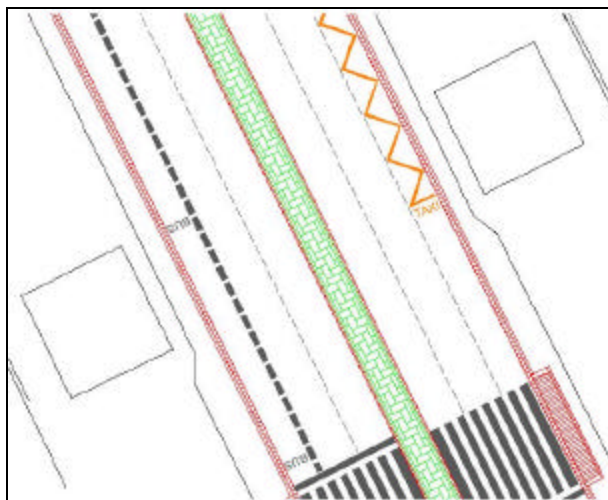
Fig. 11. Width doubled in front of the Venecian towers

- The sidewalks are projected wider in accordance with the reduction of the carriageway. Passing the Towers, the width shall be doubled and the pedestrians can walk in more comfortable conditions. The bus-stop dispose of a platform with more useful space (Fig. 11).

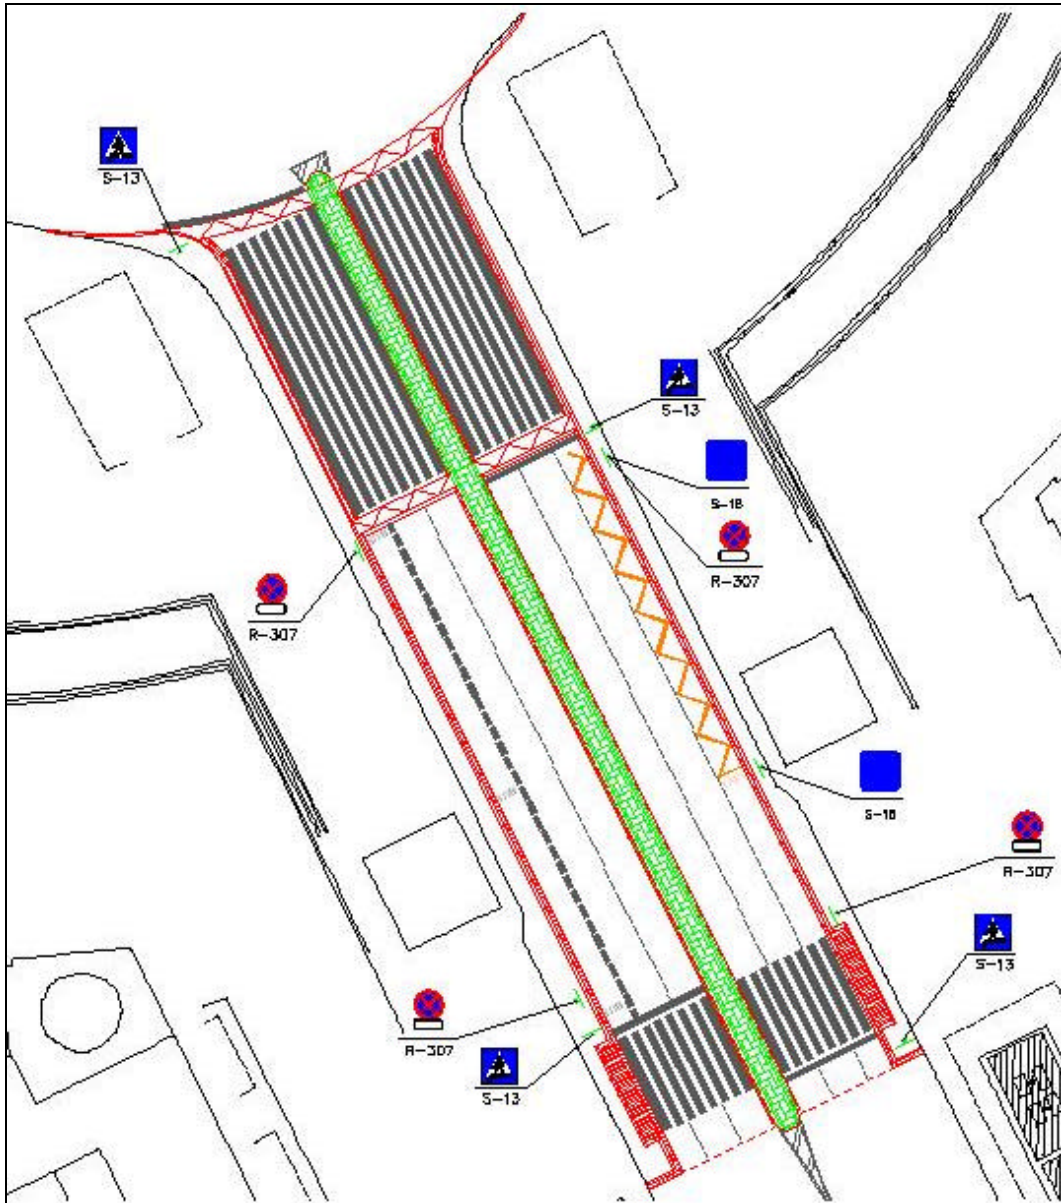
Fig. 12. New design and signing

- With the new design and signing, the zone get better conditions for the pedestrians, without imposing too many restrictions to the drivers (except during the special events) (Fig. 12).
